REFERENCE:	Nova Bus Manuals
SECTION:	16: Electrical system
RS N°:	MQR 7621-1331
EFFECTIVE IN PROD.:	LB45 (2018AL)

SUBJECT:	Throttle pedal sensors (TPS) cable replacement			
JUSTIFICATION:	Cummins code 1242 for throttle pedal sensor circuit			
LEVEL	DESCRIPTION	DIRECT CHARGES		TIME
		LABOUR	MATERIAL	
1	Install the throttle pedal sensor bypass cable.	Client	Client	2.75 h
2	Install the throttle pedal sensor front to back cable.	Client	Client	16 h

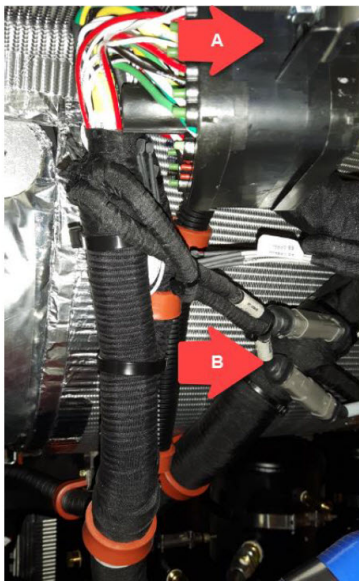
FUEL PEDAL – EMI interference close to Alternator

Instructions Spéciales/ Special Instruction		
#	Action	Commentaires / Comments
	Déplacer	<p>Les x2 connecteurs (MT-X9564E) sont situés trop près de l'alternateur, ce qui altère le signal d'accélération de la pédale à carburant (EMI). Déplacer les connecteurs de la localisation A à la localisation B.</p> <p>The 2 connectors (MT-X9564E) are located too close to the alternator and create EMI to the fuel pedal signal. Need to move connector from location A to location B (see picture)</p>

- If DCP-504300 was not properly implemented, relocate the two TPS cable connectors further away from the alternator by following the instructions provided.

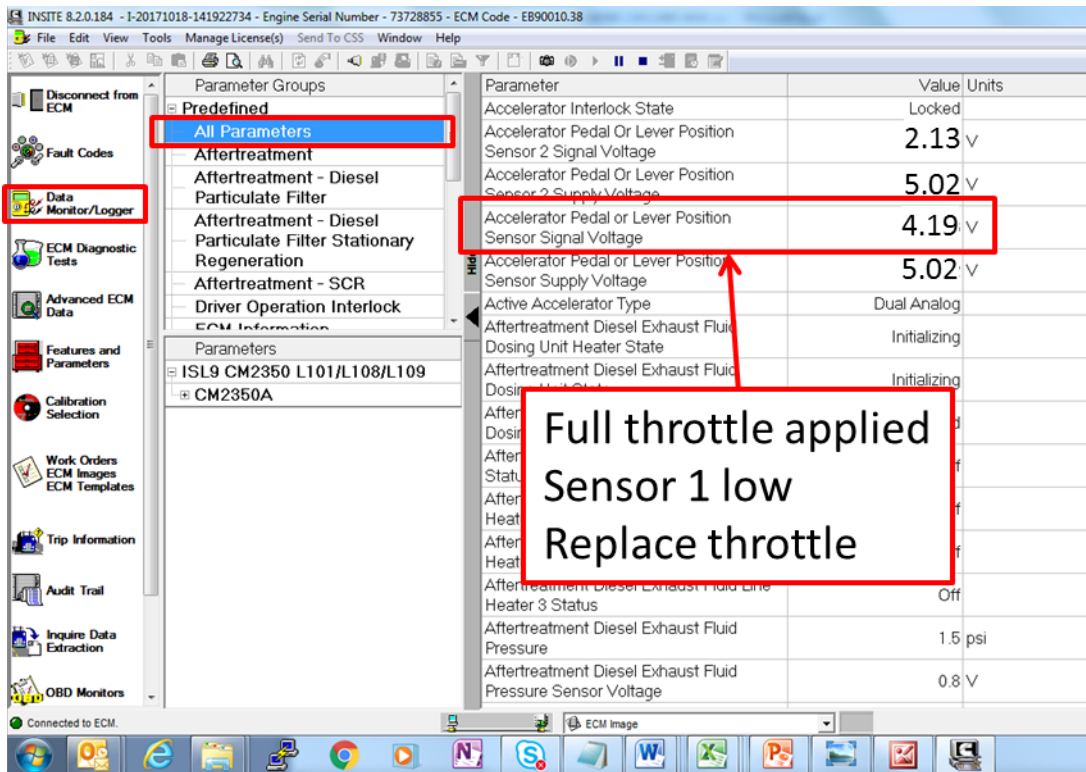
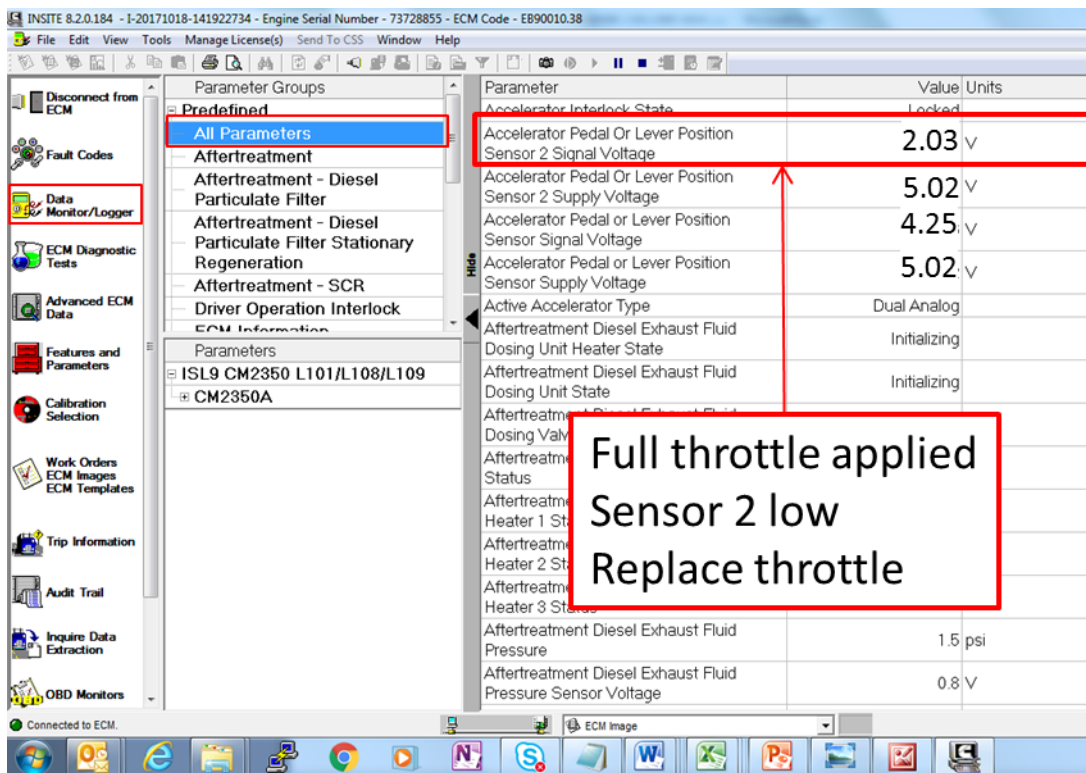
Figure A3.3. Example of INSITE Abnormal (FAIL) Readings at Full Throttle Pedal Position

- **Good APS 1 (PASS condition):**
 - Reading is 4.25 V and steady when throttle pedal fully depressed.
- **Bad APS 1 (FAIL condition):**
 - Reading is unstable with throttle pedal being held steady.
- **Bad APS 1 (FAIL condition):**
 - Reading is around 4.19 V (low).
- **Good APS 2 (PASS condition):**
 - Reading is 2.13 V and steady when throttle pedal fully depressed.
- **Bad APS 2 (FAIL condition):**
 - Reading is unstable with throttle pedal being held steady.
- **Bad APS 2 (FAIL condition):**
 - Signal 2 is about 2.03 V (low).

Note: Any of the abovementioned bad APS readings (FAIL condition) should normally lead to 1242 FC activation.

4. Test the throttle pedal operation (see Appendix 3 for the throttle pedal testing procedure).
 - If the throttle pedal test fails with the 1242 FC, then replace the throttle pedal with a new or spare unit (previously tested / known-good unit), test drive the bus and finally return it to service if the 1242 FC does not return.
