Technical Service Bulletin

91 SOS warning displayed in instrument cluster, DTCs B105313 and B153313 stored in the data bus diagnostic interface

91 19 54 2054812/1 April 25, 2019.

Model(s)	Year	VIN Range	Vehicle-Specific Equipment
A4, A5	2018 - 2019	All	With connected gateway and eCall

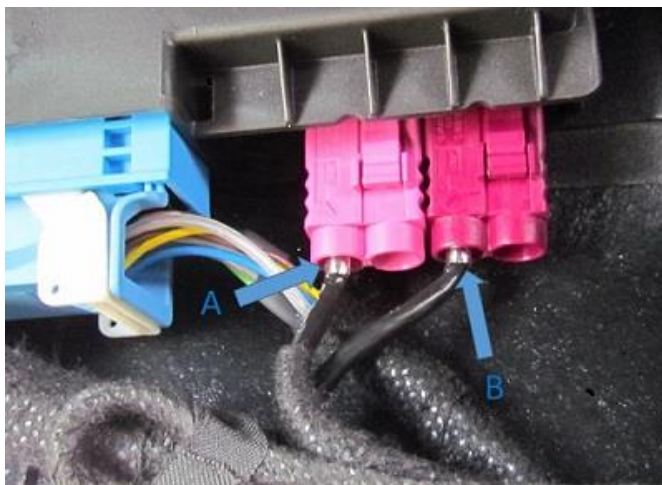
Poor contact at one of the coaxial wiring's FAKRA connections between data bus on board diagnostic interface, J533 (address word 0019) and one of the external antennas for emergency call services.

DTC Reference Table			
DTC	Measured Value Diagnostic Address 0019	Cable Position (Figure 1)	Vehicle PR-Codes
B105313 GSM antenna Open circuit	Antenna for telephone status 0x24E2	A	IW3 IW5 + 4GR IW5 + 4GY
B153313 GSM antenna 2 Open circuit	Status of antenna 2 for phone 0x1836	B	IW3 IW5

Figure 1. GSM antenna location reference at the data bus on board diagnostic interface, J533 (address word 0019).

1. If DTC B105313 or B153313 are found in the data bus on board diagnostic interface, J533 (address word 0019), then replace the coaxial wire from the applicable emergency call module antenna to the data bus on board diagnostic interface, J533 (address word 0019).
2. Utilize the VAS 6720 to build a single coaxial wire from the emergency call module to the data bus on board diagnostic interface, J533 (address word 0019).
 - **Do not** split the new wire at the TIM connection between T2dkx and T2dk.
 - Route the new wire along with the existing harness.
 - Ensure that there are no sharp bends.
 - Ensure there is no tension on the new contacts.
 - The cable should be 8.7ft (2.65m) in length.
