Technical Service Bulletin

91 SOS warning displayed in instrument cluster, DTCs B105313 and B153313 stored in the data bus diagnostic interface

91 19 55 2054630/1 April 25, 2019.

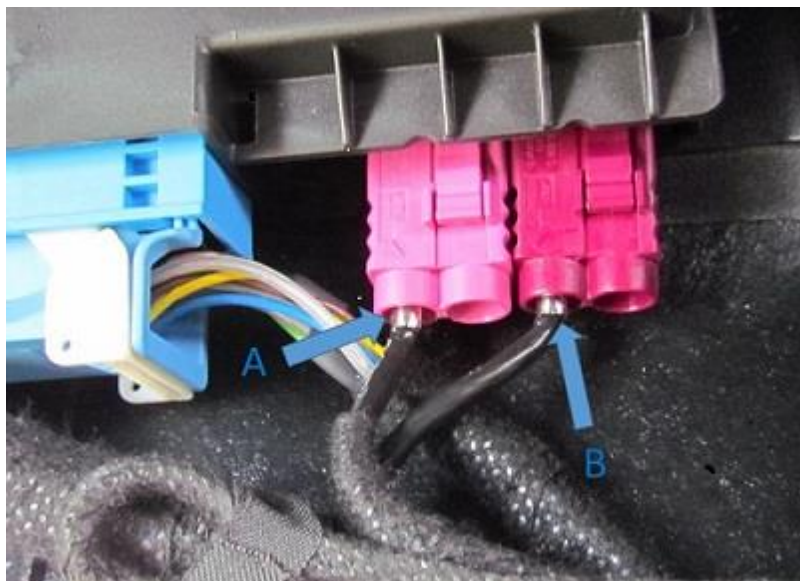
Poor contact at one of the coaxial wiring's FAKRA connections between data bus on board diagnostic interface, J533 (address word 0019) and one of the external antenna's for emergency call services.

Figure 1. GSM antenna location reference at the data bus on board diagnostic interface, J533 (address word 0019).

1. Perform a visual inspection of the cable and connector.

Replace the contact utilizing the VAS 6720 if:

- There is tension on the cable. The cable should have some slack.
- The pin is bent or cracked.
- The cable is bent or damaged.
- The connector is not fully connected.
