Title: Cab Water Leak Troubleshooting Tips

Applies To: LT, RH, ProStar, and Lonestar sleeper cabs. However some aspects may also apply to all cabs in the High Performance Vehicle family - MV, HV, LT, RH, ProStar, LoneStar, TransStar, WorkStar(HV), DuraStar(MV), and TerraStar. 9000i, PayStar(HX), CityStar, or LoadStar are not covered in this document.

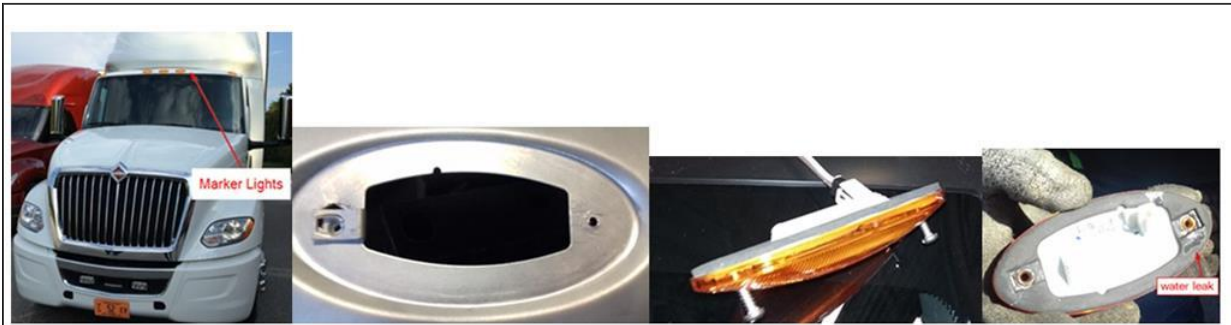
- Each marker light is held in place with two #8 SS sheet metal screws. One goes directly into the cab roof and the other goes into a U-nut clip. Sometimes the U-nut tears the foam gasket. Sometimes the screw that goes directly into the cab roof strips the hole and causes the gasket not to compress and seal. Add a new U-nut to the stripped hole location.
- Remove each marker light to inspect and verify seal integrity. (See attached photos for example of defective seal.)
- Check all five marker lights as more than one could be leaking.

Be sure to remove and inspect all five marker light seals and be careful to not over torque the fasteners upon reinstallation.

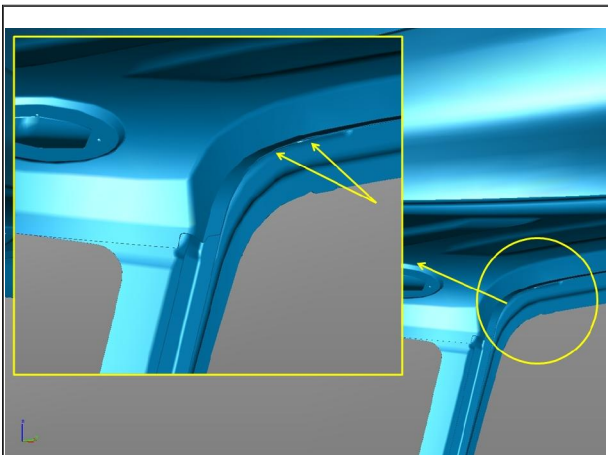
Although this seam is covered by the door seal, water can work its way under the seal and through this seam if this seam is not sealed properly at the factory.

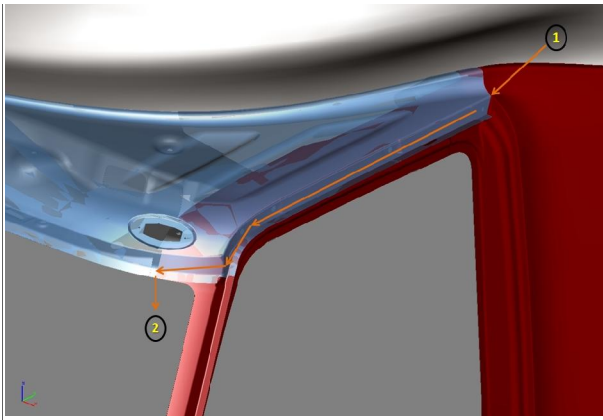
5. Cab seam above the rear corner of the door
- Water typically presents itself during or shortly after driving through inclement weather or when subjected to a truck wash.
 - Water drips from above the driver or passenger side door.
 - Water drips from the top of the windshield on the outboard driver or passenger side (approximately below where the outboard sunshade mounting points are located).

1. Water enters here.
2. Water exits here and drips down the inside of the windshield.

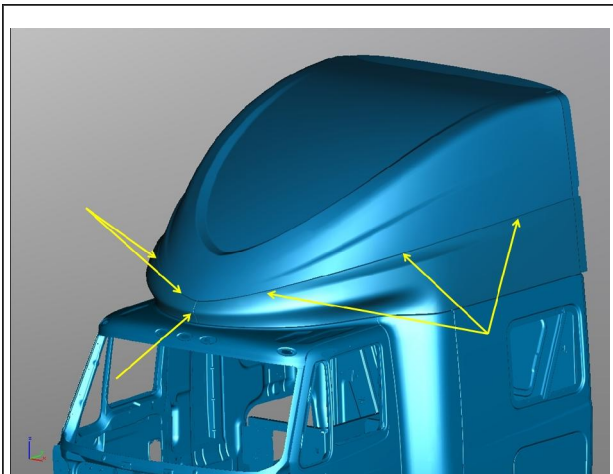
All roof seams should be checked for cracks or voids in the sealer.

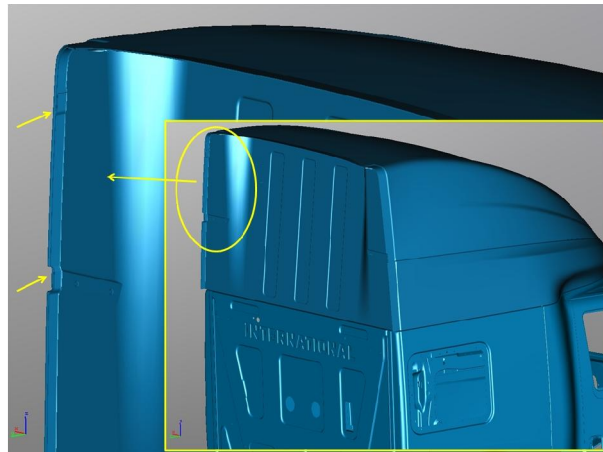
Seams at the rear corners of the Skyrise cab should be checked for voids.

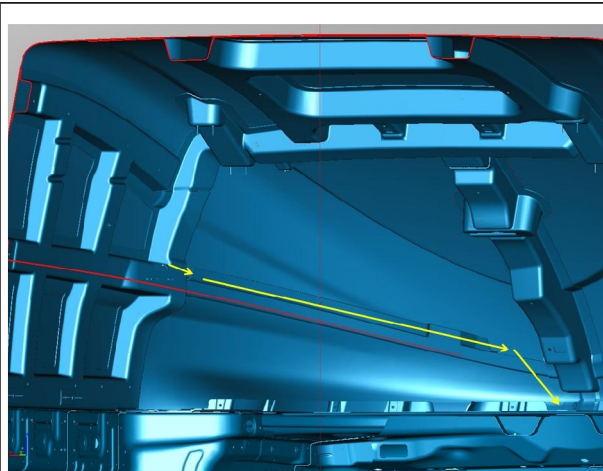
After penetrating the outer seams, water can travel along internal reinforcement bond lines, ultimately draining into the trough formed by the lower roof panel and dumping near the front center of the driver compartment.

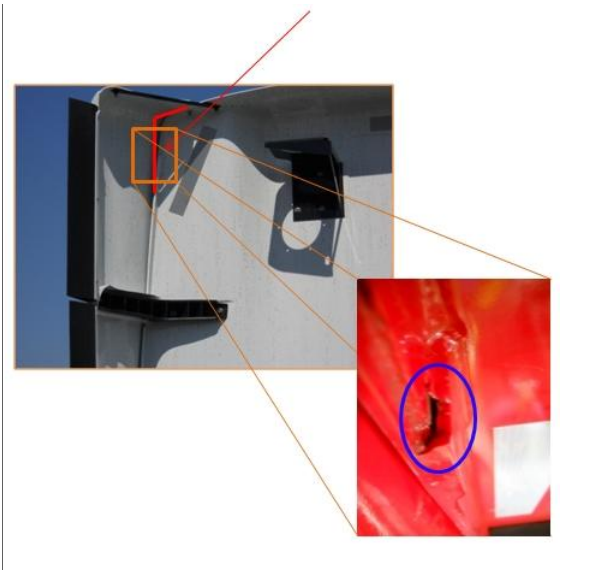
Top Photo - Driver side shown, passenger side symmetrically opposite.

This area is illustrated due to its obscurity as a water entry point. These instructions can be used on any roof seam that exhibits a void or inconsistency in sealer.

1. Using IPA (isopropyl alcohol) clean the seams/joints and any other suspect locations (visible voids/gaps) in the immediate area. Look to be sure the black plastic plug is not missing. If plug is missing replace with service part plug. (P/N: 498376C1)

2. Allow the surfaces to dry.
3. Apply Dow® BETASEAL™ (2611723c1) to the same areas cleaned in Step 1.
4. Immediately wipe off the surfaces (prolonged exposure to the Dow® primer could damage the paint). These surfaces are now prepped for good adhesion to the sealer.
5. Apply Bostik® SuperTrans™ (2611726c1) to the prepped surfaces. Force material into the joint where possible. For best results, apply sealer into the seam wiping in both directions.
6. Allow material to dry.

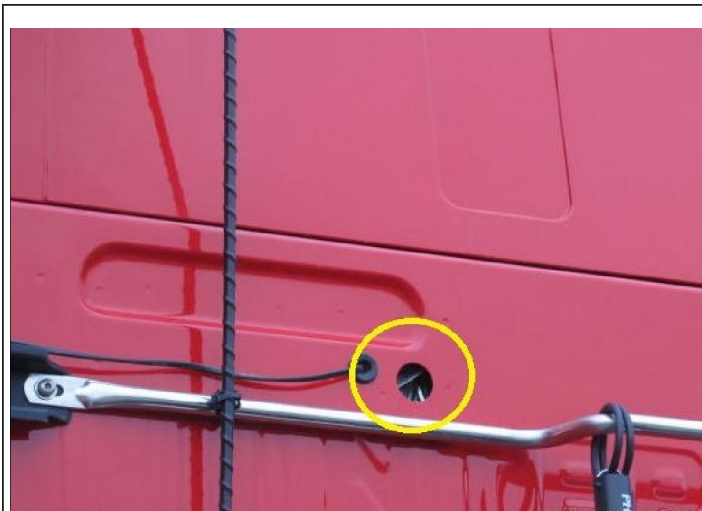
Example of missing plastic plug on BOC of most sleeper configurations. If this plug is missing; replace it with new one from service parts (p/n: 498376C1)

Note: When inspecting BOC on Sleepers - Look to be sure the black plastic plug is not missing. If plug is missing replace with service part plug. (P/N: 498376C1)
