Countries:	CANADA, UNITED STATES, MEXICO, PUERTO RICO	Document ID:	IK1600251
Availability:	ISIS, FleetSIS, IsSIR	Revision:	0
Major System:	CAB / SLEEPER / HOOD	Created:	3/15/2019
Current Language:	English	Last Modified:	4/1/2019
Other Languages:	NONE	Author:	Steven Bautz
Viewed:	96

Title: Water Leaks Past Plastic Vapor Barrier Sheet in the Inner Cavity of the Cab Entry Door

Applies To: Any Cab Entry Door on LT, RH, HV, MV, 2018 LoneStar

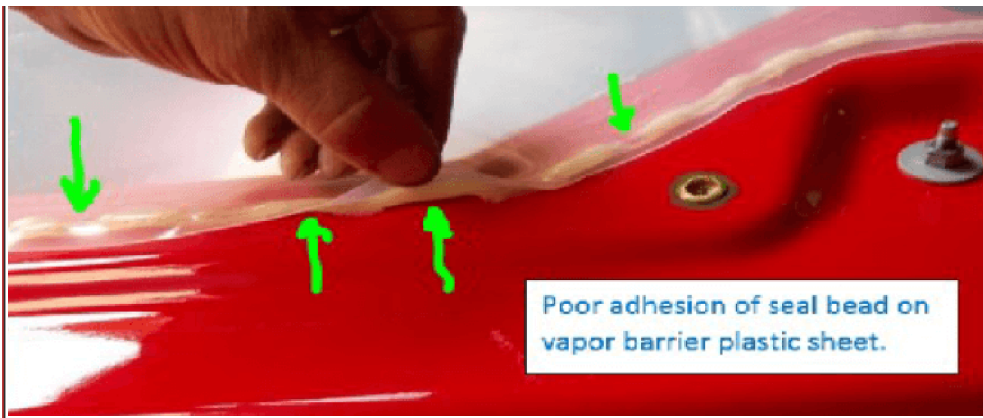
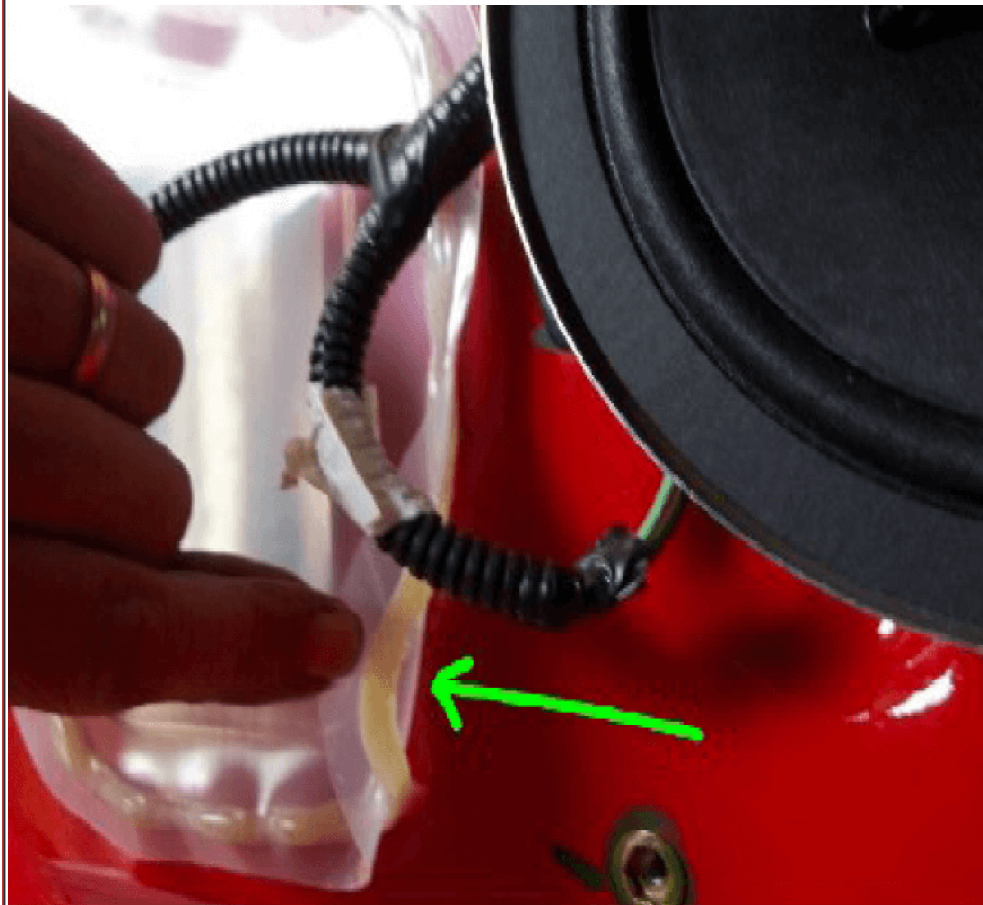
Step	Inspection for seal bead adhesion to metal door panel	Procedure
2		<ol style="list-style-type: none"> <li data-bbox="1203 1346 1469 1402">1. Check for adhesion by water leaking or dripping <li data-bbox="1203 1409 1469 1549">2. Slightly lift plastic vapor barrier all around each sealed location to check for adhesion to metal door panel.
