Technical Service Bulletin

96 Lane change assist does not work, DTCs C1114F0 and C1114F3 stored in lane change assistance control modules

96 19 37 2048470/2 April 17, 2019. Supersedes Technical Service Bulletin Group 96 number 17-18 dated August 4, 2017 for reasons listed below.

Model(s)	Year	VIN Range	Vehicle-Specific Equipment
Q5	2018	All	With Audi pre sense

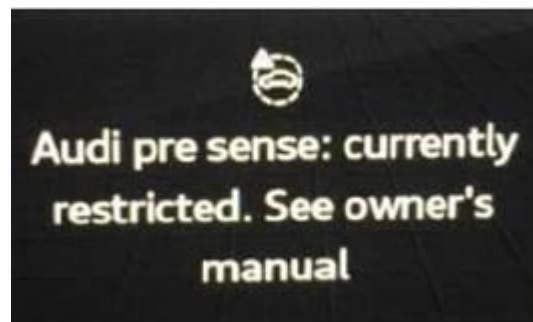
- Message in instrument cluster “Audi pre sense: currently restricted. See owner’s manual”

Figure 1. Message in the instrument cluster.

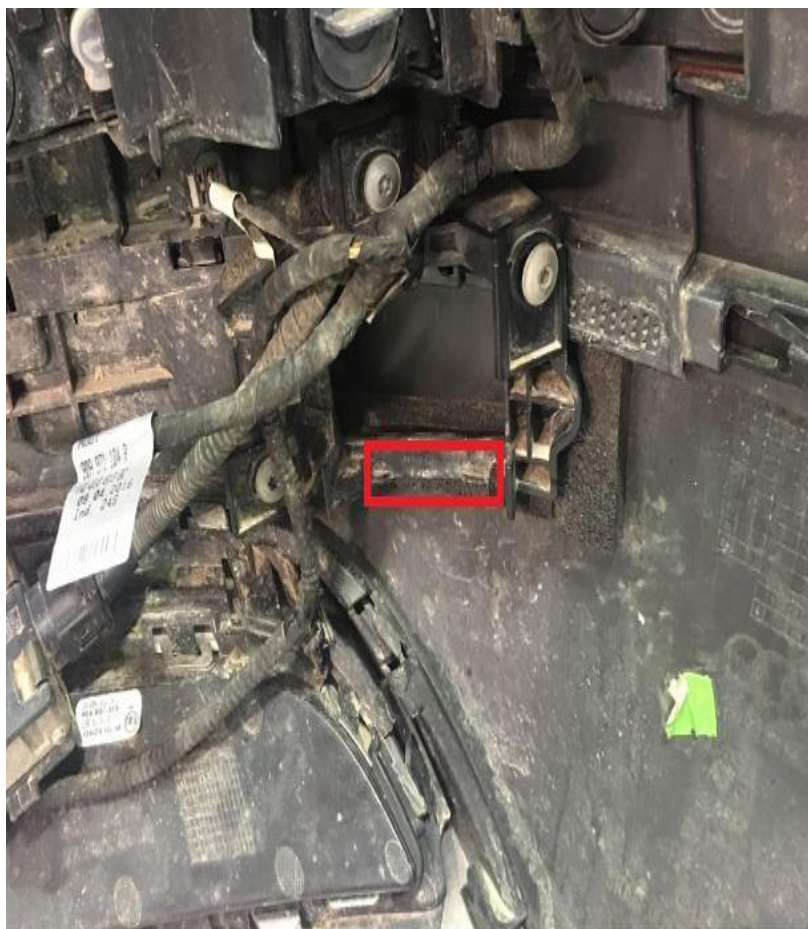
Figure 2. Bracket part number located on driver's side.

1. Before removing the bumper, check the bracket part numbers (Figure 2 and 3). If they are not part numbers 80A 907 908 B and 80A 907 907 B then proceed with the instructions below.

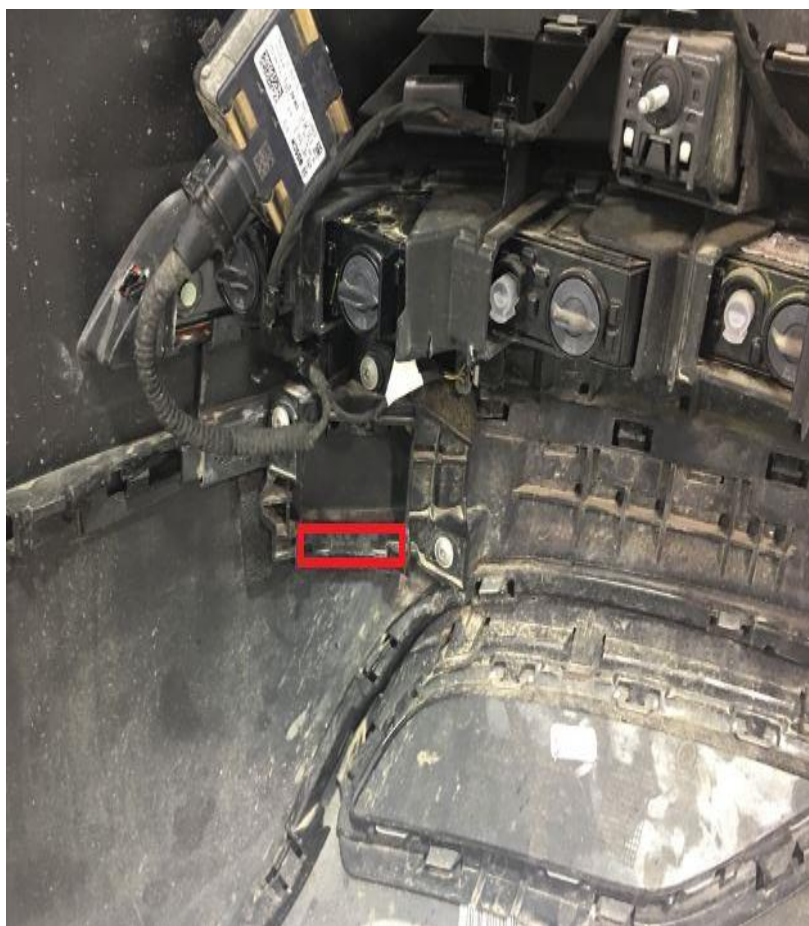
Figure 3. Bracket part number located on passenger's side.

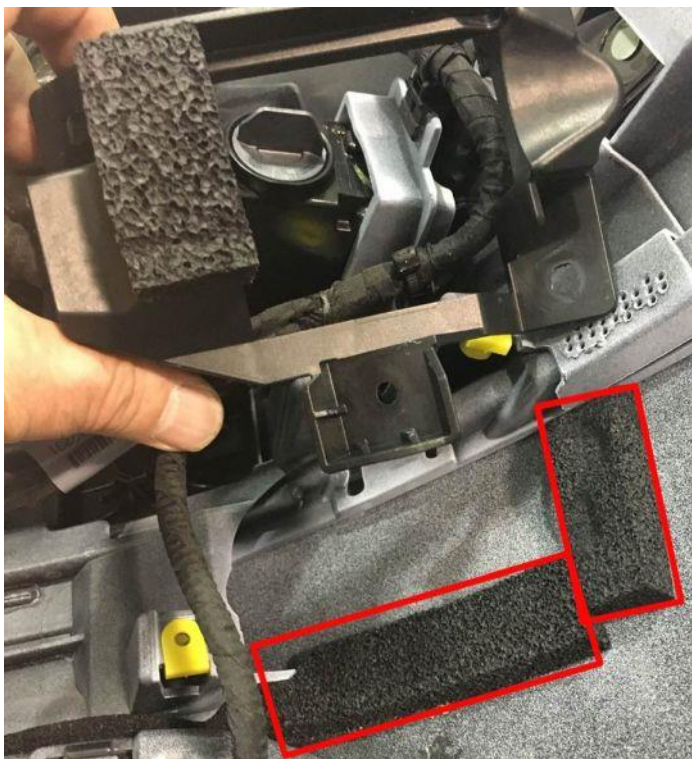
The fault most likely was caused by the improper installation of foam which interferes with the sensor's field of view.

Figure 4. Foam to be stripped out.

3. Strip out any foam that is glued to the bumper (Figure 4) marked in the red areas (Figure 5).

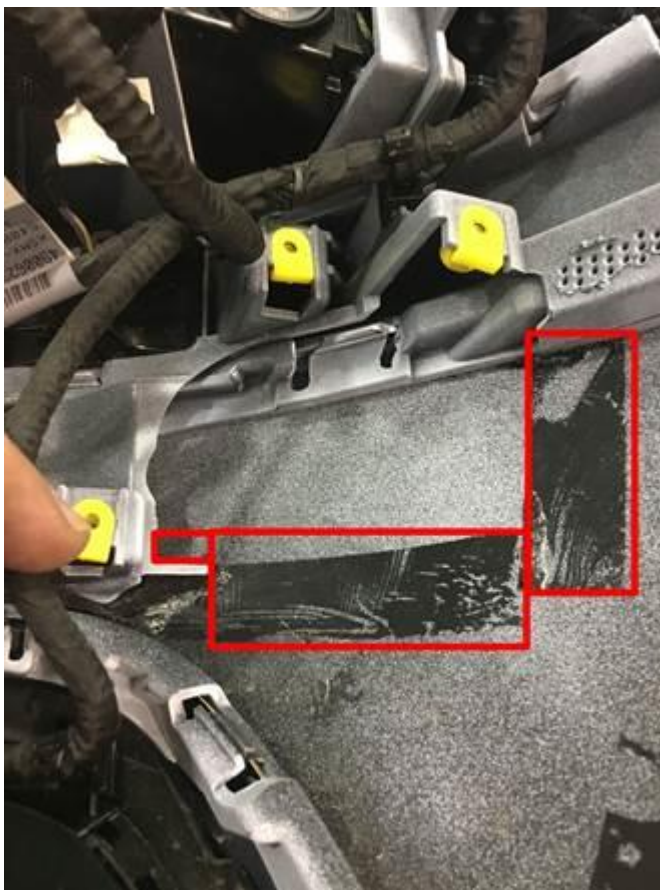
Figure 5. Removed foam.

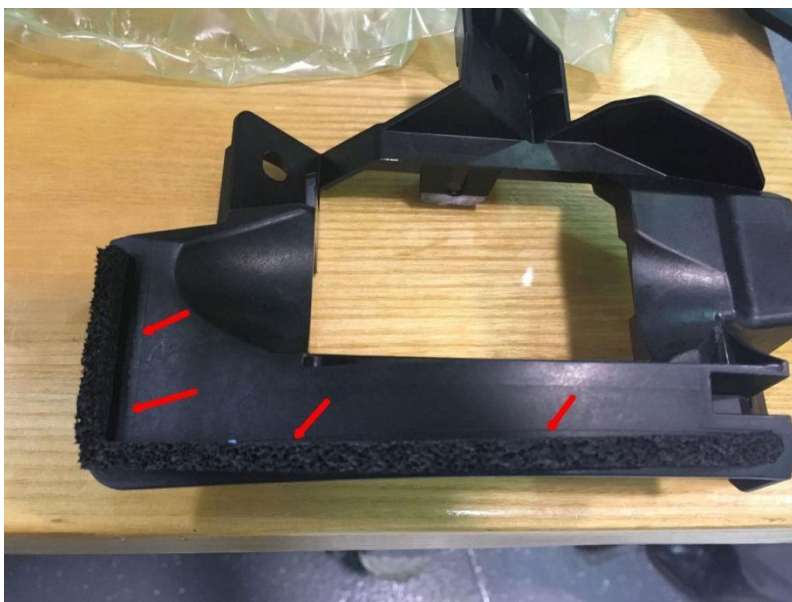
Figure 6. Indication marks for new foam.

4. Prepare the new brackets 80A 907 908 B and 80A 907 907 B by applying the foam strips 80A 807 549.

The brackets have indication marks to help to position the foam (Figure 6).
