# Service Action

## Code: 19N8

<b>Subject</b>	<b>After-Run Coolant Pump</b>
<b>Release Date</b>	April 16, 2019
<b>Affected Vehicles</b>	<b>U.S.A.: Certain 2012-2017 MY Audi vehicles with a 2.0L TFSI gasoline engine</b> <b>CANADA: Certain 2013-2017 MY Audi vehicles with a 2.0L TFSI gasoline engine</b> <i>Check Campaigns/Actions screen in Elsa on the day of repair to verify that a VIN qualifies for repair under this action. Elsa is the <u>only</u> valid campaign inquiry &amp; verification source.</i> <ul style="list-style-type: none"><li>✓ Campaign status must show "open."</li><li>✓ If Elsa shows other open action(s), inform your customer so that the work can also be completed at the same time the vehicle is in the workshop for this campaign.</li></ul>
<b>Problem Description</b>	Power to the electric (after-run) coolant pump was disconnected under Safety Recall 19N4.
<b>Corrective Action</b>	Install a new electric (after-run) coolant pump and update ECM software.

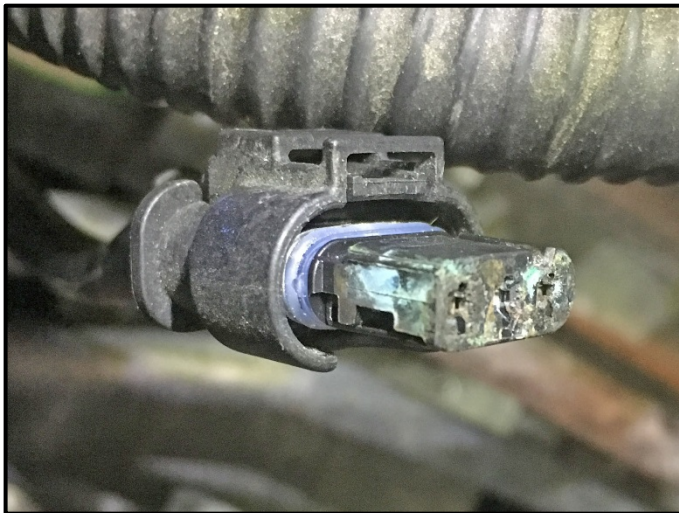
**Inspect connector to after-run coolant pump -V51-:**

- Check the wiring connector AND the coolant pump connector housing for the following:
  - Signs of overheating
  - Pin corrosion
  - Coolant intrusion
- The wiring connector housing, pins and seals must be replaced if the connector housing is found damaged at the time of repair.

Qty.	Part Number	Part Description
1	000.979.940	Butt connector for 0.5 mm wire
2	000.979.941	Butt connector for 1.0 mm wire
1	000.979.034.E	0.5 mm wire
1	000.979.159.E	1.0 mm wire
3	3C0.972.741	Wire seal
1	4H0.973.703	Connector housing

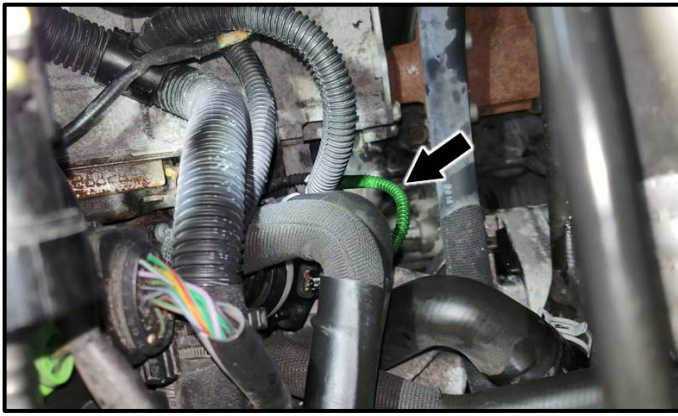
Due to the new location of the connector on the new pumps, the after-run coolant pump wiring harness <arrow> may have to be routed so it does not come into contact with the pump coolant hose.
