April 23, 2019

Version 2

2018 Accord: Rear Tray Rattles

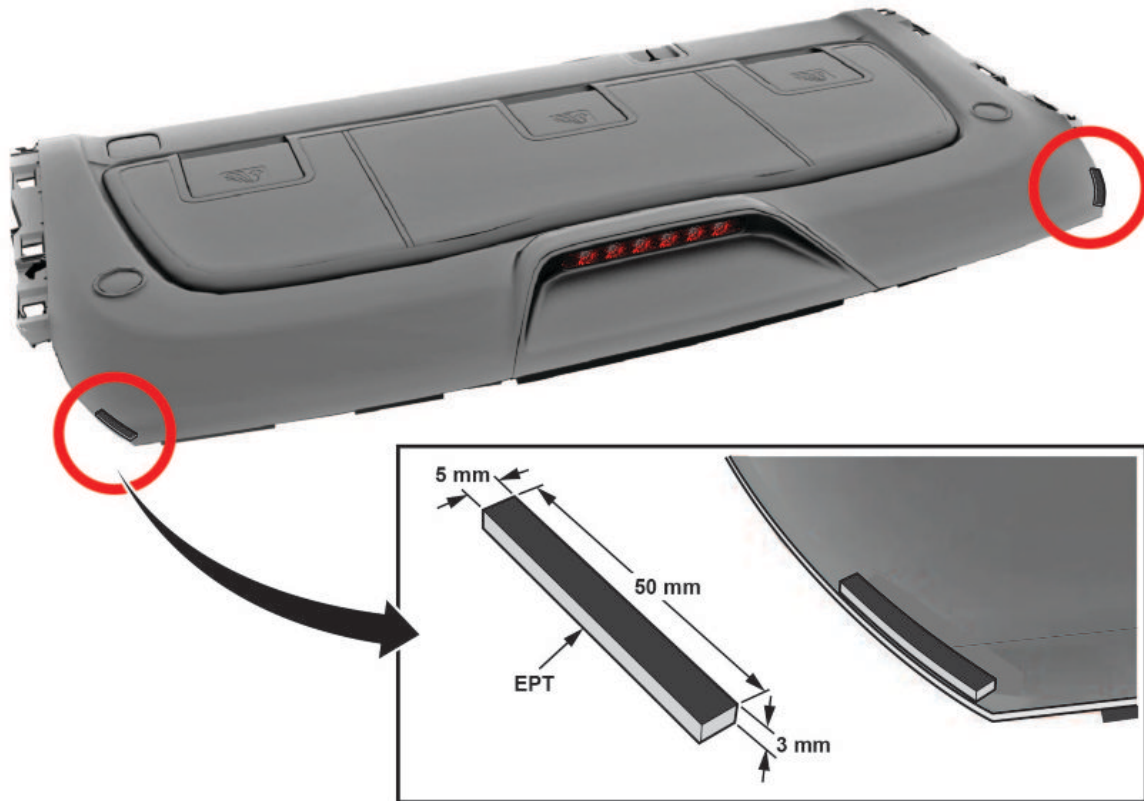
The rear tray may be warped in the back corners.

7. Cut two pieces of EPT foam **5 mm X 50 mm**.

8. Clean the surface of the rear shelf where the EPT foam will attach. Then, apply the cut pieces of EPT Foam to each corner of the rear shelf as shown.
9. Install all removed parts in the reverse order of removal.
10. Make sure the noise is gone.
