April 27, 2019

## Chatter or Rattle Near the Door Tweeter

Year	Model	Trim	VIN Range
2017	NSX	ALL	ALL

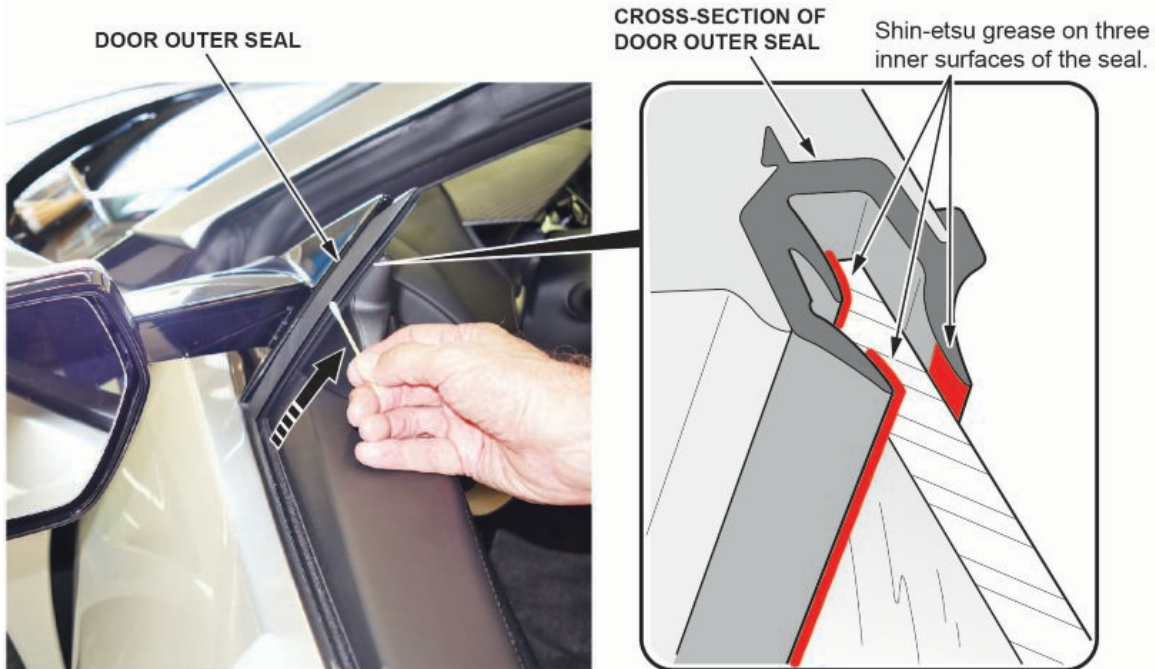
The door window(s) is vibrating against the window run channel.

2. Apply a thin, even layer of Shin-Etsu silicon grease inside the affected door outer seal (window run channel) as shown, and test-drive the vehicle.
