May 3, 2019

Version 4

A/C Does Not Blow Cold Air and Condenser Leaks at Receiver Dryer Cap

Supersedes 18-080, dated October 4, 2018, to revise the information highlighted in **yellow**

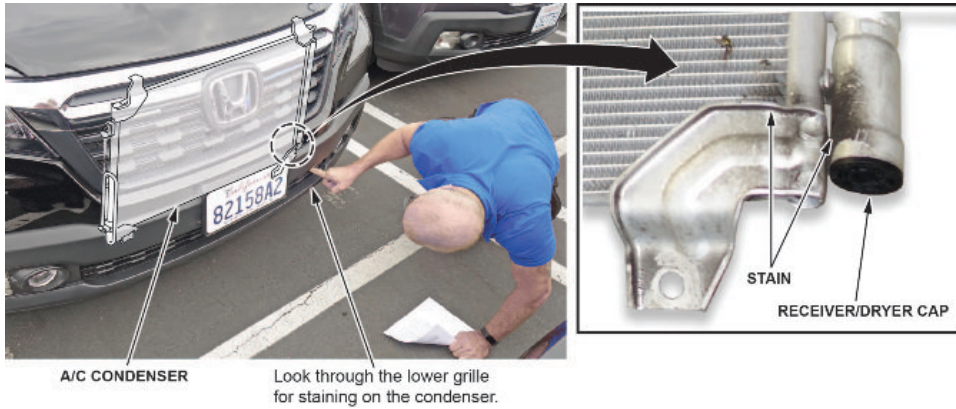
The A/C does not blow cold air, and the lower corner of the condenser around the receiver/dryer cap is stained.

There is poor O-ring compression against the receiver/dryer barrel wall.

Check if the A/C is blowing cold air and there is staining around the receiver dryer cap on the condenser.

- If the A/C is not blowing cold air and there is staining around the receiver dryer cap on the condenser, go to REPAIR PROCEDURE.
- If the A/C is not blowing cold air and there is no staining around the receiver dryer cap, continue with normal system troubleshooting.
