GLOBAL SAFETY FIELD INVESTIGATIONS
DCS4986
URGENT - DISTRIBUTE IMMEDIATELY

Subject: N182201530 - Service Update
Propeller Shaft Disengage at Power Transfer Unit

Models: 2018-2019 Buick Regal
Equipped with All Wheel Drive/Four Wheel Drive (RPO F46)

N182201530 Propeller Shaft Disengage at Power Transfer Unit

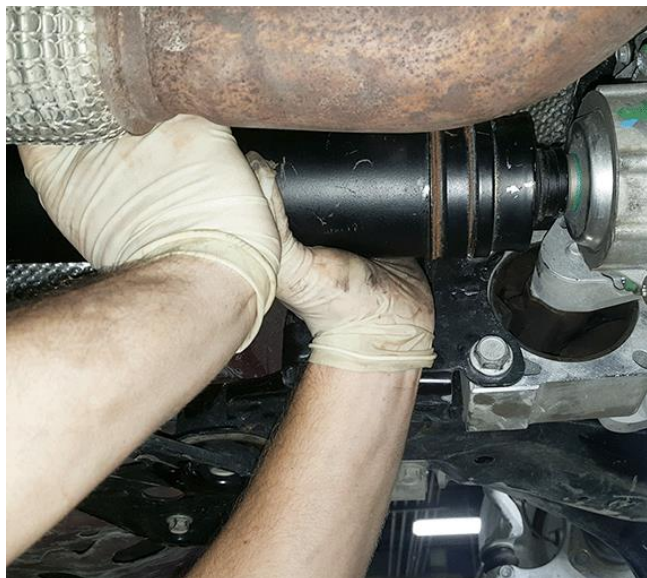
5116259

| Condition | Certain 2018-2019 model year Buick Regal vehicles, equipped with AWD (RPO F46), may have a condition in which the front portion of the propeller shaft slips out of the Power Transfer Unit (PTU) and drags on the roadway. The driver may hear a dragging noise from beneath the vehicle, but there will be no driver information center/cluster warning messages. |

2. Using both hands, push forward firmly on the driveshaft several times as shown to ensure it is snapped into the Power Transfer Unit (PTU) fully.
