GLOBAL SAFETY FIELD INVESTIGATIONS
DCS4987
URGENT - DISTRIBUTE IMMEDIATELY

Subject: N182194790 - Special Coverage
Driver's Front Seat Belt Anchor Pretensioner Cable

Models: 2011-2012 Chevrolet Malibu

N182194790 Driver's Front Seat Belt Anchor Pretensioner Cable

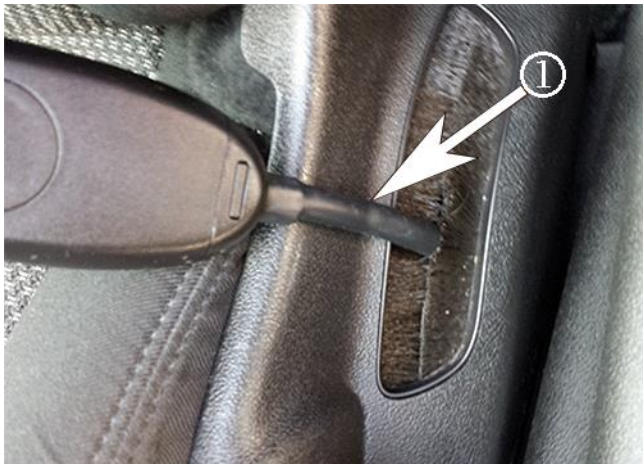
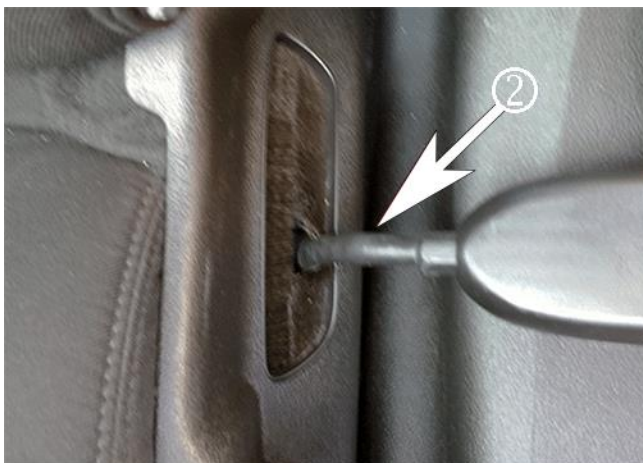
1. Move the front driver side seat to the full downward position and forward of the center pillar.

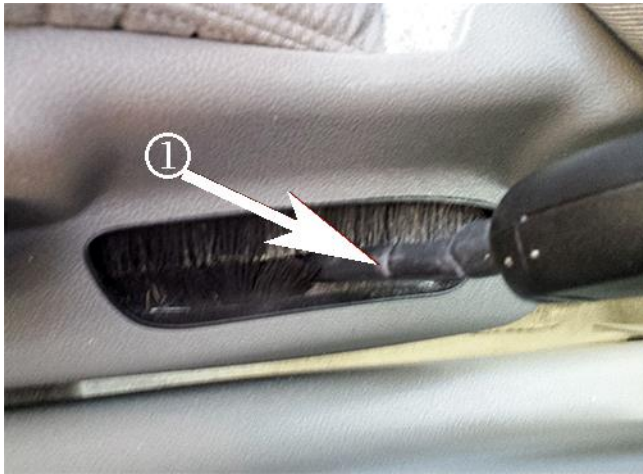
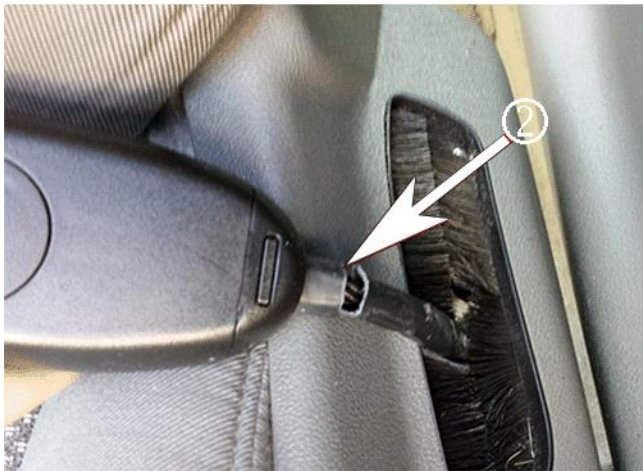
2. Inspect the safety belt shrink sleeve for any cuts or cracks. Bend the seat belt cable toward the inside (1) and outside (2) of the vehicle and carefully inspect for any cuts or cracks in the shrink sleeve.

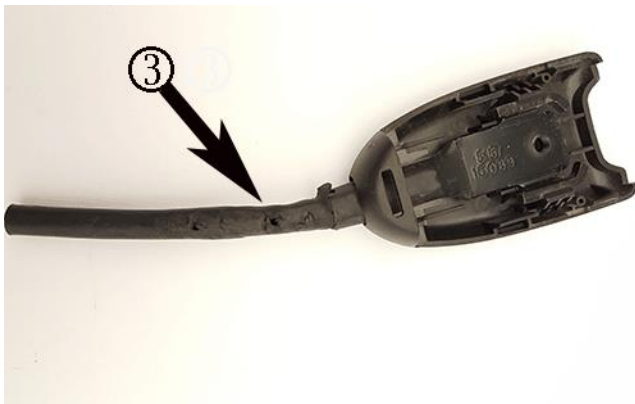
5239571

3. If a sleeve is cut or cracked on the cable (1) or where the cable meets the buckle (2), replace the front seat belt anchor plate tensioner. Refer to *Front Seat Belt Anchor Plate Tensioner Replacement* in SI.

4. If the cable has a permanent bend (3), replace the front seat belt anchor plate tensioner. Refer to *Front Seat Belt Anchor Plate Tensioner Replacement* in SI. **If no damage is found**, inform the customer that their vehicle is not displaying the condition described in the bulletin.

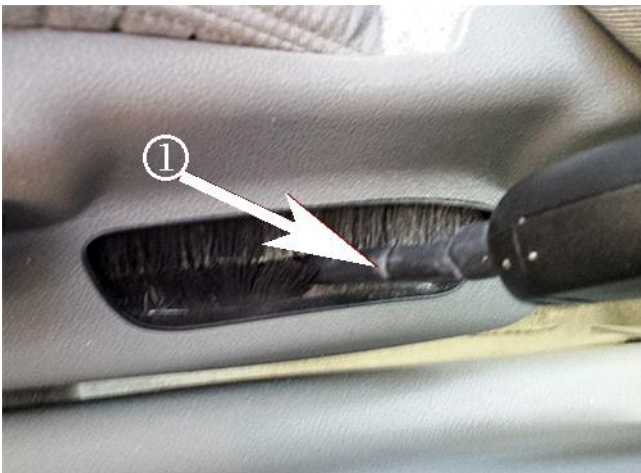
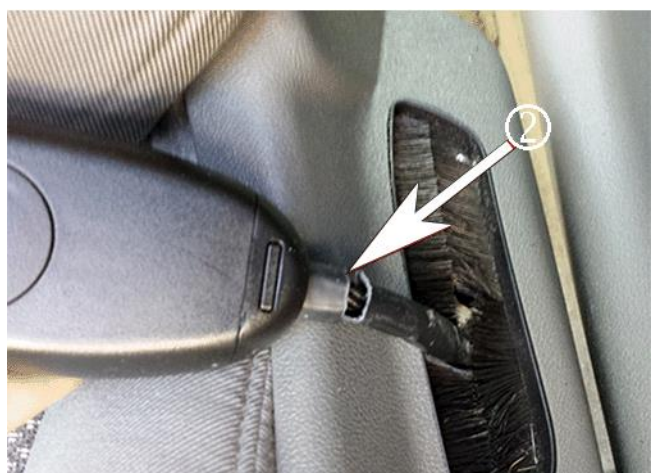
2. Inspect the safety belt shrink sleeve for any cuts or cracks. Bend the seat belt cable toward the inside (1) and outside (2) of the vehicle and carefully inspect for any cuts or cracks in the shrink sleeve.

3. If a sleeve is cut or cracked on the cable (1) or where the cable meets the buckle (2), take your vehicle to the dealer for further inspection.
