Subject: N192212090 - Service Update
Rear Bumper Corrosion

Models: 2019 Chevrolet Silverado 1500 (New Model)
2019 GMC Sierra 1500 (New Model)

Service Update

N192212090 Rear Bumper Corrosion

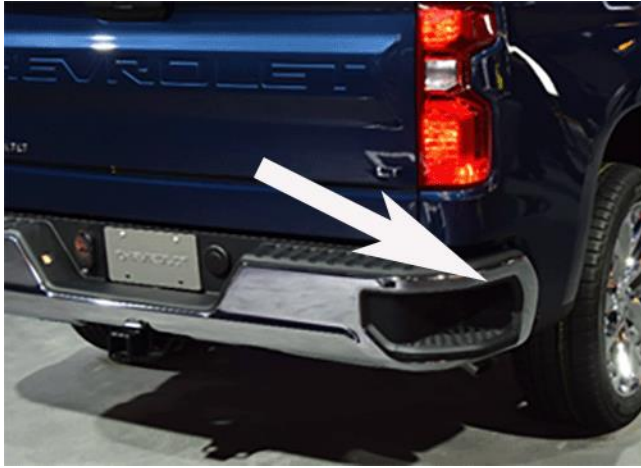
1. If required, use a damp towel to clean the left and right bumper ends. Ensure the area around the step pocket is clean and dry.
2. Inspect the areas around the left and right step pockets for any sign of rust.

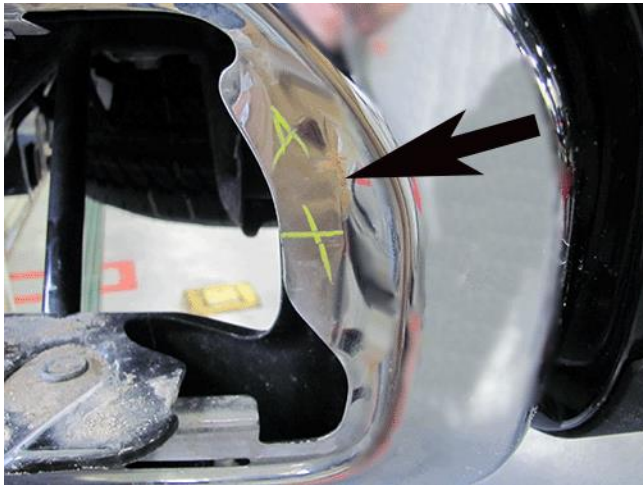
5246999

4. If any rust is found on the rear bumper impact bar under the step pad assembly, use warm water and car wash detergent to remove the rust. Rinse thoroughly and dry.
