GLOBAL SAFETY FIELD INVESTIGATIONS  
DCS4989  
URGENT - DISTRIBUTE IMMEDIATELY

Subject: N192210460 - Service Update  
eBoost Control Module Software False Detection with DTC Associated

Models: 2019 Cadillac CT6 w/ LSY or LTA motors  
2019 Chevrolet Silverado 1500 (New Model)  
2019 GMC Sierra 1500 (New Model)

## N192210460 eBoost Control Module Software False Detection with DTC Associated

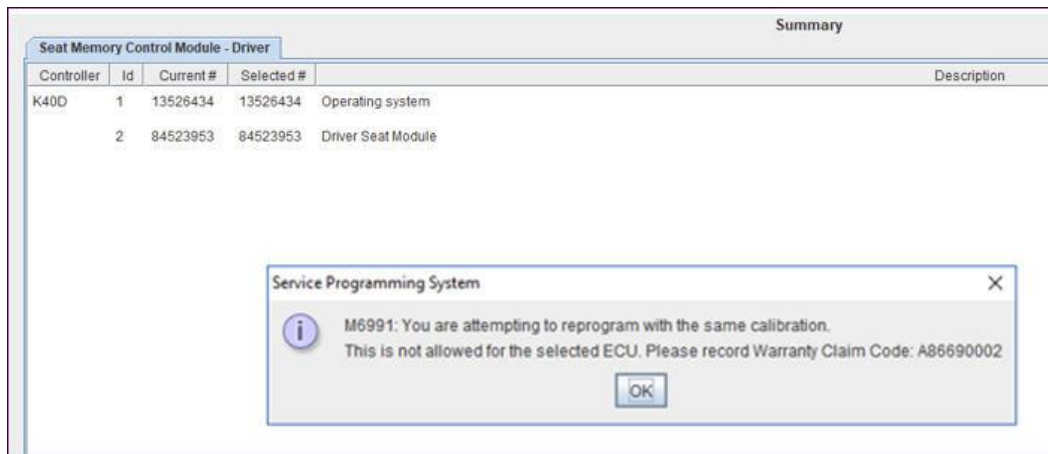
5164840

- Turn OFF or disable systems that may put a load on the vehicles battery such as; interior lights, exterior lights (including daytime running lights), HVAC, radio, etc.
- Clear DTCs after programming is complete. Clearing powertrain DTCs will set the Inspection/Maintenance (I/M) system status indicators to NO.

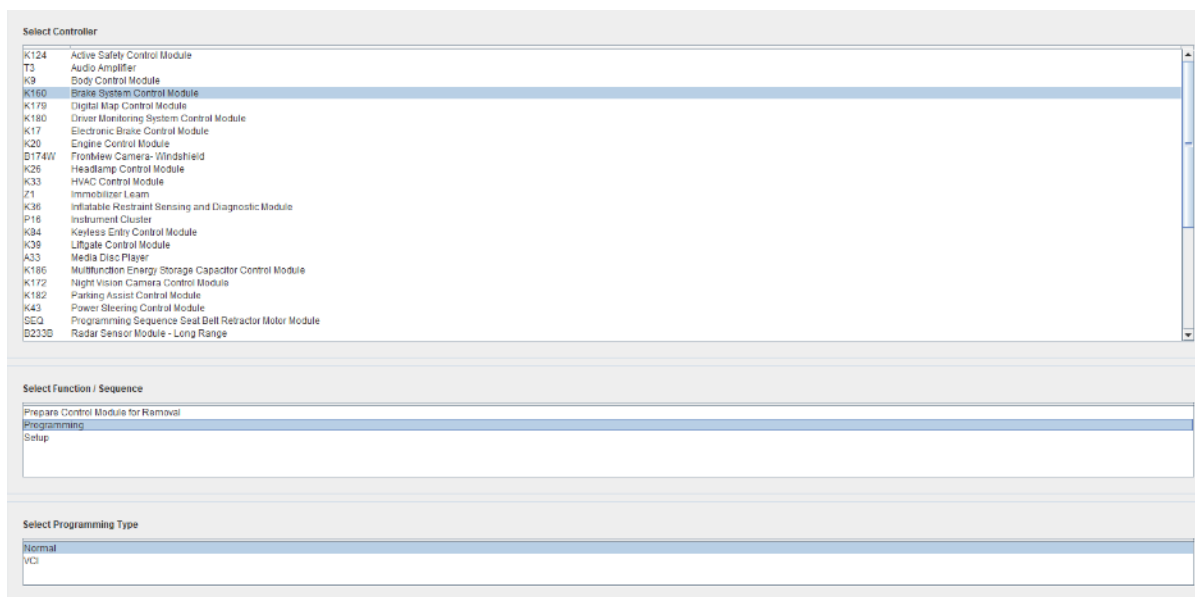
5263446

**Note:** If the Same Calibration/Software Warning is noted on the SPS Summary screen, record the warranty claim code (WCC) and select OK and follow screen instructions. The WCC is located in the Service Programming System dialogue box of the SPS Summary screen. No further action is required. Refer to the Warranty section of the bulletin.
