GLOBAL SAFETY FIELD INVESTIGATIONS
DCS4994
URGENT - DISTRIBUTE IMMEDIATELY

Subject: N192208640 - Service Update
Engine Runs Rough, Stall, No Restart Due To Damaged Ground
Terminal

Models: 2019 Chevrolet Blazer

N192208640 Engine Runs Rough, Stall, No Restart Due To Damaged Ground Terminal

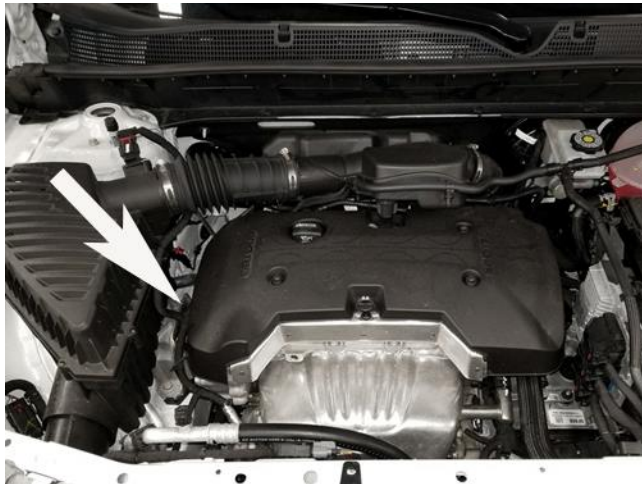
5271337

1. Open the vehicle hood and locate the G113 ground terminal ring on the right (passenger) side of the engine.
2. Verify the correct installation of the ground terminal ring to the engine. A mechanics mirror may help obtain a better view.

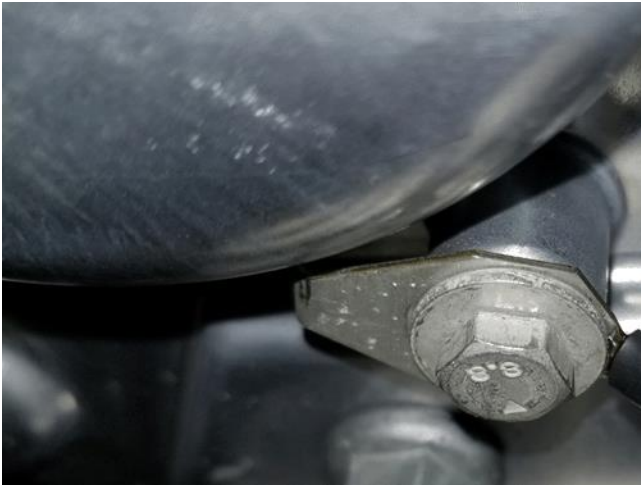
5271604

- If the tab on the ground terminal is positioned toward the rear of the engine compartment (as shown), no further action is required.

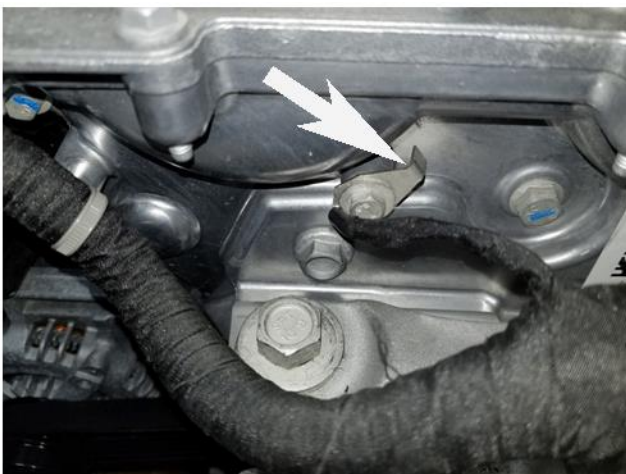
5271605

- If the ground ring tab is rotated in a different direction, the wire connection on the ring is bent or there appears to be a strain on the wire, proceed to step number 3.
3. Remove the air cleaner assembly. Refer to *Air Cleaner Assembly Replacement* in SI.
 4. Unbolt the G113 ground terminal ring from the engine.
 5. Unwrap the harness tape from the G113 branch.
