GLOBAL SAFETY FIELD INVESTIGATIONS
DCS4995
URGENT - DISTRIBUTE IMMEDIATELY

Subject: N182200080 - Service Update
Decreased Acceleration - Hesitation

Models: 2019 Buick Enclave
2019 Buick LaCrosse
2019 Cadillac XT4
Equipped with 9-speed automatic transmission (RPO M3W, M3G, M3H)

N182200080 Decreased Acceleration - Hesitation

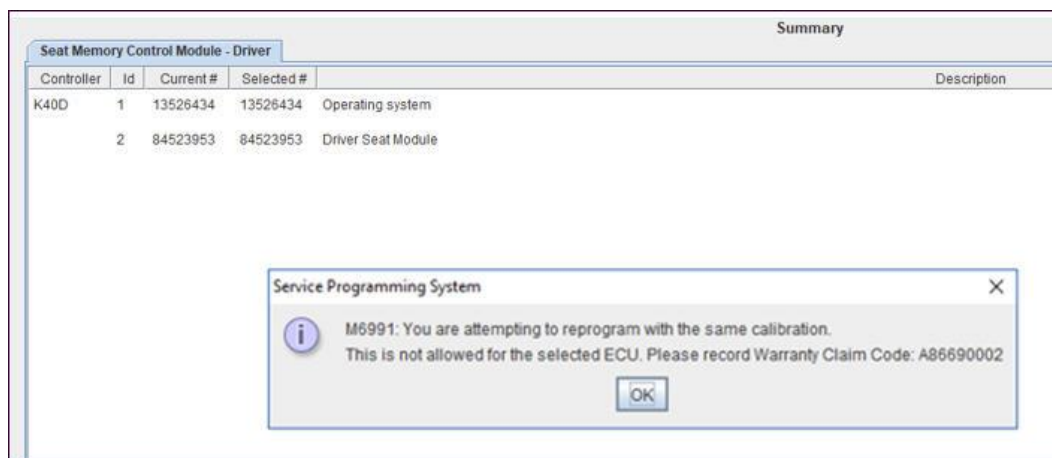
5164840

Note: If the Same Calibration/Software Warning is noted on the SPS Summary screen, record the warranty claim code (WCC) and select OK and follow screen instructions. The WCC is located in the Service Programming System dialogue box of the SPS Summary screen. No further action is required. Refer to the Warranty section of the bulletin.
