GLOBAL SAFETY FIELD INVESTIGATIONS
DCS4998
URGENT - DISTRIBUTE IMMEDIATELY

Subject: N192210920 Service Update
Poor Engine Control Module (ECM) Retention

Models: 2019 Chevrolet Corvette
Equipped with Performance Package Special Coupe (RPO ZR1)

N192210920 Poor Engine Control Module (ECM) Retention

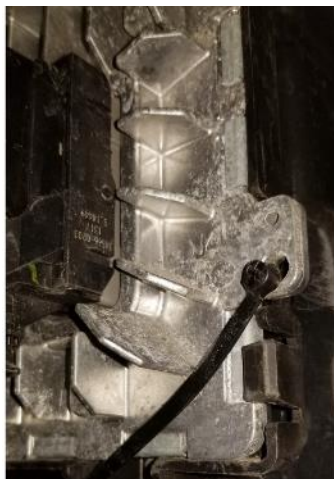
5280625

Condition	Certain 2019 model year Chevrolet Corvette (RPO ZR1) vehicles may have the engine control module (ECM) not completely retained in the bracket behind the right-hand side of the front fender. The ECM could become loose and cause a rattle in the fender.
Correction	Dealers are to tie strap the ECM to the bracket.

1. Remove the required components to gain access to the engine control module (ECM). Refer to *Engine Control Module Replacement* in SI for reference. The engine control module does not need to be removed or disconnected.
