Subject: N182188910-01 - Special Coverage  
PPS Setting DTC For Airbag Light On  
Updated Customer Letter

Models: 2017 Buick Verano

## N182188910 – PPS Setting DTC For Airbag Light On

**Revision:** 01

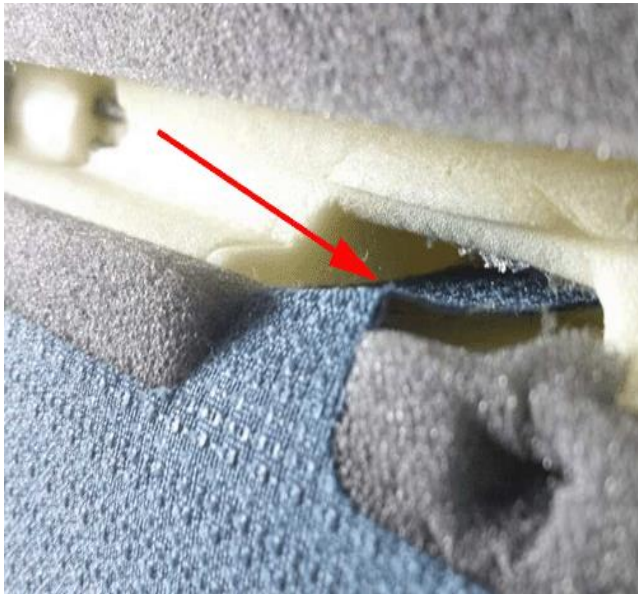
4502711

**Note:** Crease observed in tail area from top side.

2. Upon inspection of the sensor after trim removal, a sharp crease in the passenger presence sensor in the area where the sensor tail exits through to the bottom of the seat cushion assembly may be observed.

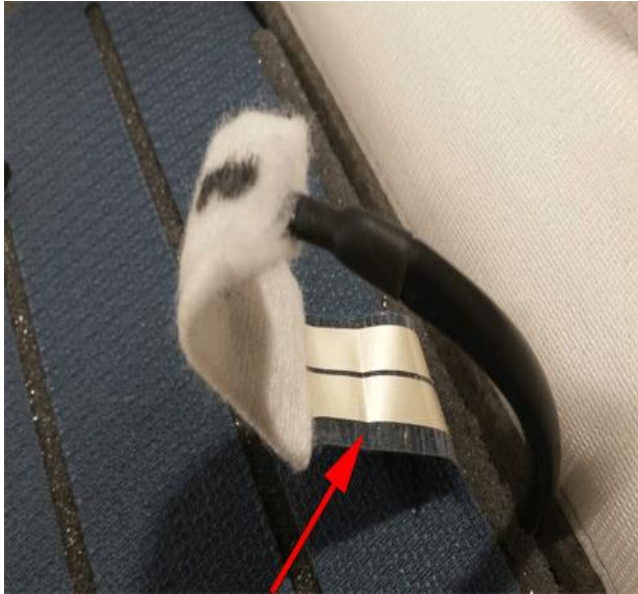
4505464

**Note:** Crease observed in tail area from bottom side.

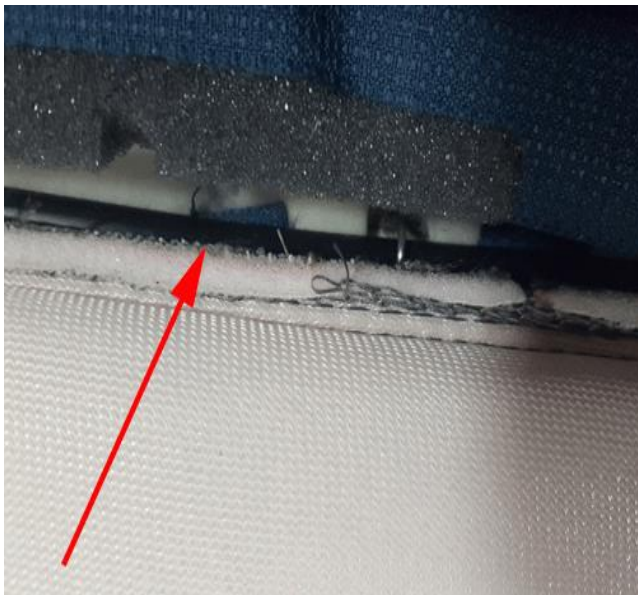
4505465

**Note:** Sensor tail observed trapped between seat trim tiedown feature and cushion pad.
