Subject: N182188930-01 - Special Coverage
Auxiliary Transmission Cooler Line Fluid Leak
Customer Reimbursement Labor Codes Added

Models: 2017-2018 Chevrolet Silverado HD
2017-2018 GMC Sierra HD
Equipped with L5P (Duramax Diesel Engine)

N182188930 Auxiliary Transmission Cooler Line Fluid Leak

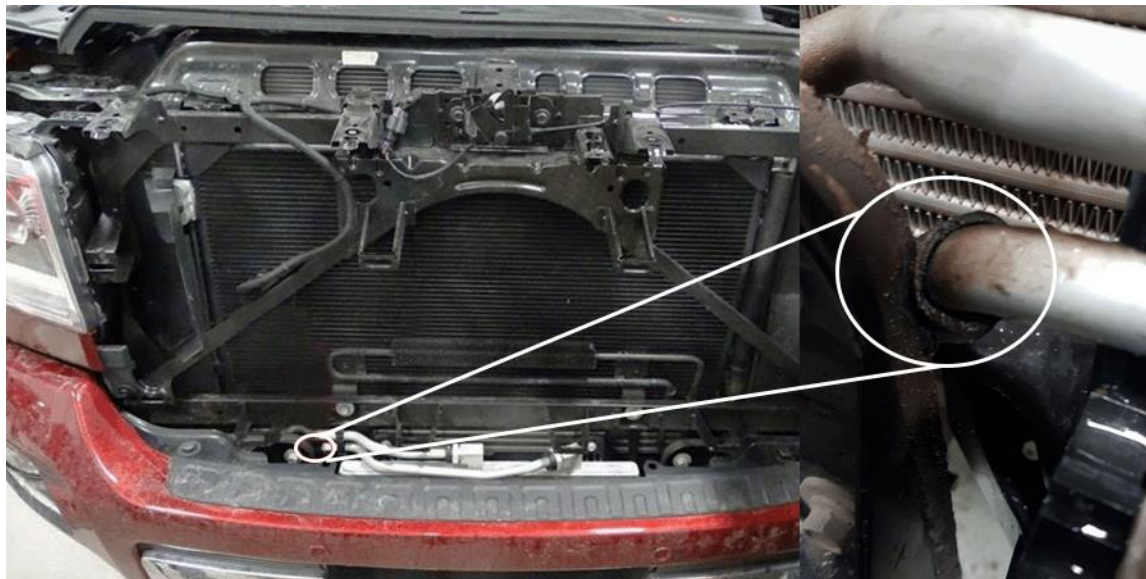
5165323

Condition	Some 2017-2018 model year Chevrolet Silverado HD and GMC Sierra HD vehicles equipped with a Duramax Diesel engine, the transmission cooler lines may be rubbing on the front frame/bumper mount bracket. This condition could cause the cooler lines to leak. Transmission fluid may be seen on the ground under the front bumper. Some drivers may have difficulty selecting gears or experience transmission slip.
Special Coverage Adjustment	<p>This special coverage covers the condition described above for a period of 6 years or 72,000 miles (116,000 km), whichever occurs first, from the date the vehicle was originally placed in service, regardless of ownership.</p> <p>For vehicles covered by Vehicle Service Contracts, all eligible claims with repair orders on or after January 3, 2019, are covered by this special coverage and must be submitted using the labor operation codes provided with this bulletin. Claims with repair orders prior to January 3, 2019, must be submitted to the Service Contract provider.</p> <p>Vehicle owners or lessees who paid for repairs referenced in this Special Coverage ("Customers") are eligible for reimbursement of their reasonable and customary expenses in accordance with the procedures specified below. The conditional right to reimbursement is provided by GM solely in the interest of customer satisfaction and is personal to Customers. <i>Customers may not assign and GM does not consent to any assignment of any Customer's right to submit reimbursement claims, or to receive reimbursement, or any other rights granted by this Special Coverage to any third party, including but not limited to service contract providers, and this Special Coverage is not intended to and does not confer any third party beneficiary, subrogation or contribution rights, or any other rights to reimbursement, against GM, whether in law, equity or otherwise, on any third parties.</i></p>

- Determine if the Transmission Fluid Cooler Thermal Bypass Valve lines are leaking from a rub-through condition in the area shown (or another area near the thermal bypass valve). If necessary, use a borescope to aid in pinpointing the leak without vehicle disassembly.
 - If the lines exhibit a rub-through condition and are leaking, proceed to step 2.
 - If the lines do not exhibit a rub-through condition (or are leaking from a non-rub-through condition) no further action is required. Any further repairs and/or diagnosis are not covered under this special coverage.
- Replace the Transmission Fluid Cooler Thermal Bypass Valve. Refer to *Transmission Fluid Cooler Thermal Bypass Valve Replacement (L5P With MW7)* in SI.

Correction	Dealers are to replace the transmission cooler lines. The repairs will be made at no charge to the customer.
