GLOBAL SAFETY FIELD INVESTIGATIONS DCS5008 URGENT - DISTRIBUTE IMMEDIATELY

Subject: N192210330 - Service Update

Cruise Control Indicator and Digital Speed Not Displaying (U.S. Only)

Models: 2019 Chevrolet Silverado 1500 (New Model)

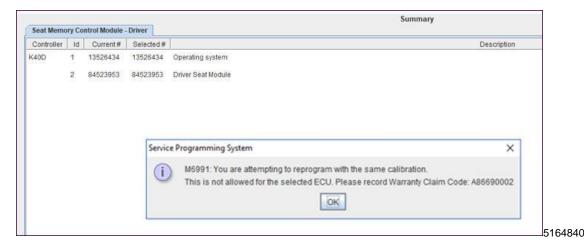
Note: If the Same Calibration/Software Warning is noted on the SPS Summary screen, record the warranty claim code (WCC) and select OK and follow screen instructions. The WCC is located in the Service Programming System dialogue box of the SPS Summary screen. No further action is required. Refer to the Warranty section of the bulletin.
