Technical Service Bulletin

SUBJECT:			No: TSB-19-54-001REVII
QUICK CHARGING WITH ABB QUICK CHARGER STOPS DUE TO ISOLATION ERROR - REVISED			DATE: April 2019
			MODEL: 2016-2017 i-MiEV, 2018-2019 Outlander PHEV
CIRCULATE TO:	<input type="checkbox"/> GENERAL MANAGER	<input checked="" type="checkbox"/> PARTS MANAGER	<input checked="" type="checkbox"/> TECHNICIAN
<input checked="" type="checkbox"/> SERVICE ADVISOR	<input checked="" type="checkbox"/> SERVICE MANAGER	<input checked="" type="checkbox"/> WARRANTY PROCESSOR	<input type="checkbox"/> SALES MANAGER

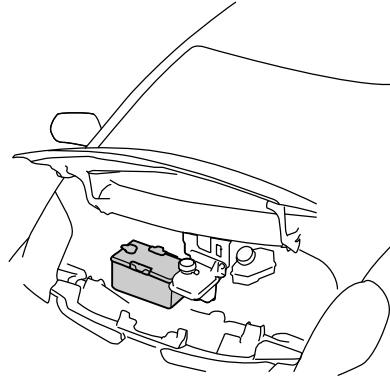
12V Starter Battery Location: i-MiEV

Under Hood

To ensure that the vehicle battery maintains 12V during the procedure, hook-up a battery charger to the 12V starter battery during the procedure.

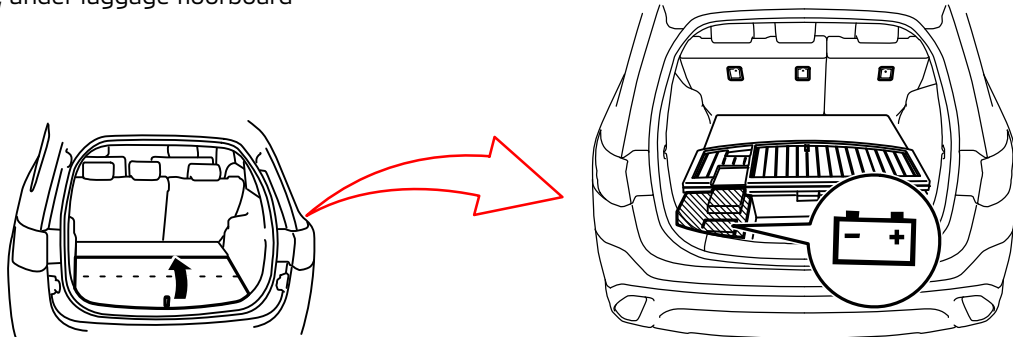
12V Starter Battery Location: Outlander PHEV

Rear of vehicle, under luggage floorboard
