Technical Service Bulletin

SUBJECT:		No: TSB-19-54-011	
SMARTPHONE NOT REGISTERING TO MITSUBISHI CONNECT		DATE: April 2019	
		MODEL: 2018-19 Eclipse Cross	
CIRCULATE TO:	<input type="checkbox"/> GENERAL MANAGER	<input checked="" type="checkbox"/> PARTS MANAGER	<input checked="" type="checkbox"/> TECHNICIAN
<input checked="" type="checkbox"/> SERVICE ADVISOR	<input checked="" type="checkbox"/> SERVICE MANAGER	<input checked="" type="checkbox"/> WARRANTY PROCESSOR	<input type="checkbox"/> SALES MANAGER

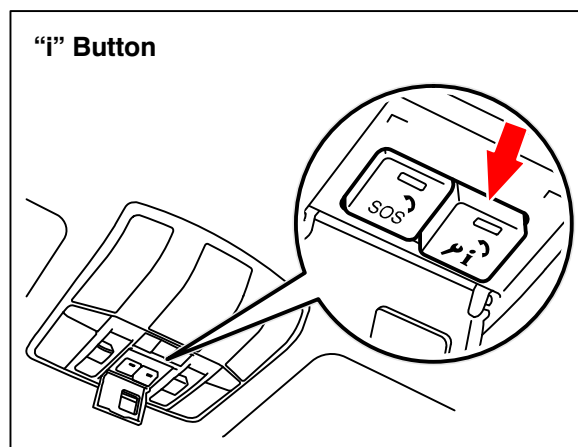
Sometimes when registering a customer's smartphone to a vehicle with the Mitsubishi Connect system, the phone may not register. This is most likely due to a weak phone signal. Follow the Registration Tips below to successfully register the smartphone to Mitsubishi Connect.

If there is difficulty registering a smartphone to Mitsubishi Connect, try the following steps.

1. Move the vehicle to a location where the phone signal is strong.
2. Repeat the registration process until the call connects to the call center.
