Technical Service Bulletin

SUBJECT:		No: TSB-19-13-003	
ENGINE DOES NOT RESTART AND/OR FAILSAFE MODE OCCURS DUE TO FROZEN RELAYS - REVISED		DATE: April 2019	
		MODEL: See below	
CIRCULATE TO:	<input type="checkbox"/> GENERAL MANAGER	<input checked="" type="checkbox"/> PARTS MANAGER	<input checked="" type="checkbox"/> TECHNICIAN
<input checked="" type="checkbox"/> SERVICE ADVISOR	<input checked="" type="checkbox"/> SERVICE MANAGER	<input checked="" type="checkbox"/> WARRANTY PROCESSOR	<input type="checkbox"/> SALES MANAGER

This bulletin supercedes TSB-18-13-003, issued December, 2018, to add Eclipse Cross, applicable Canadian models, and countermeasure dates. Revisions are italicized and indicated by ◀.

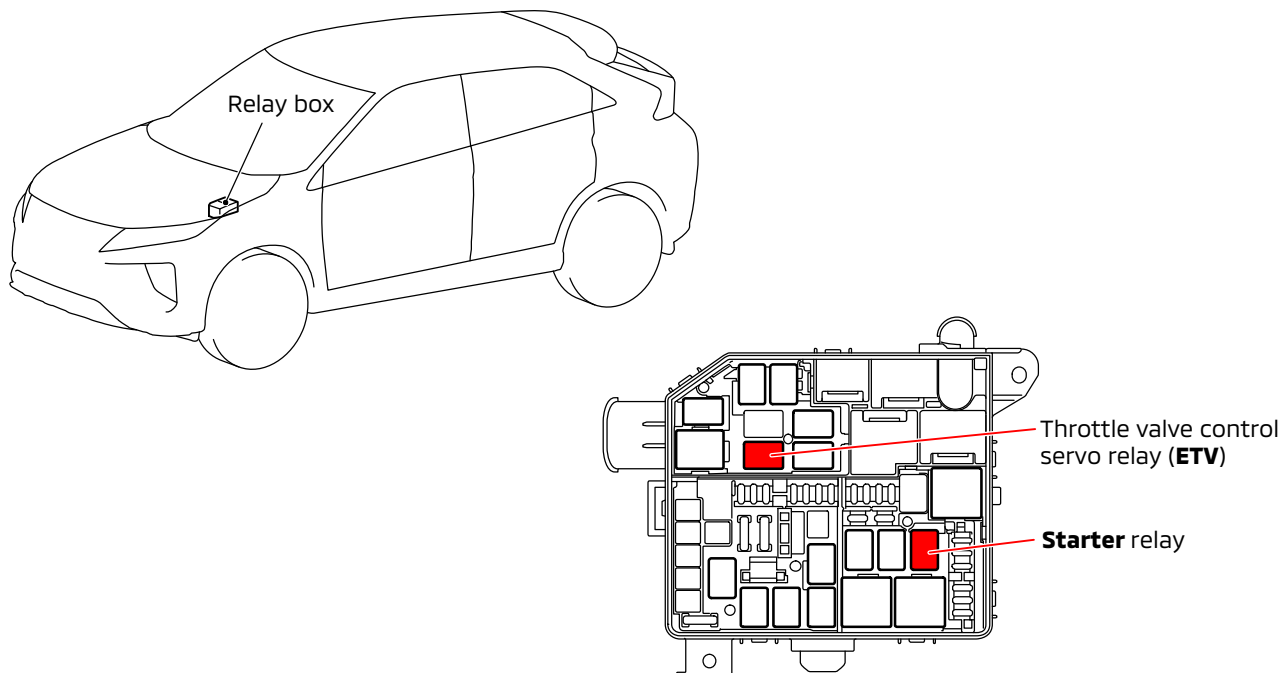
Eclipse Cross (2018-2019) Relay Locations

RELAY	DTC	SYSTEM	SYMPTOM
ETV	C121C	ASC	Rough idling, no revolution up
	C1707		
	P0657	ENGINE	
STARTER	P0616	ENGINE	No acceleration, no shifting

▶ **If ALL DTCs listed above are present for the systems shown, replace the following relays with the anti-freezing type listed below.**

RELAYS TO REPLACE	PART NUMBER (anti-freezing type)	PART NAME	RELAY TYPE	QTY
ETV	8627A049	RELAY, POWER	Micro ISO	1
STARTER				1

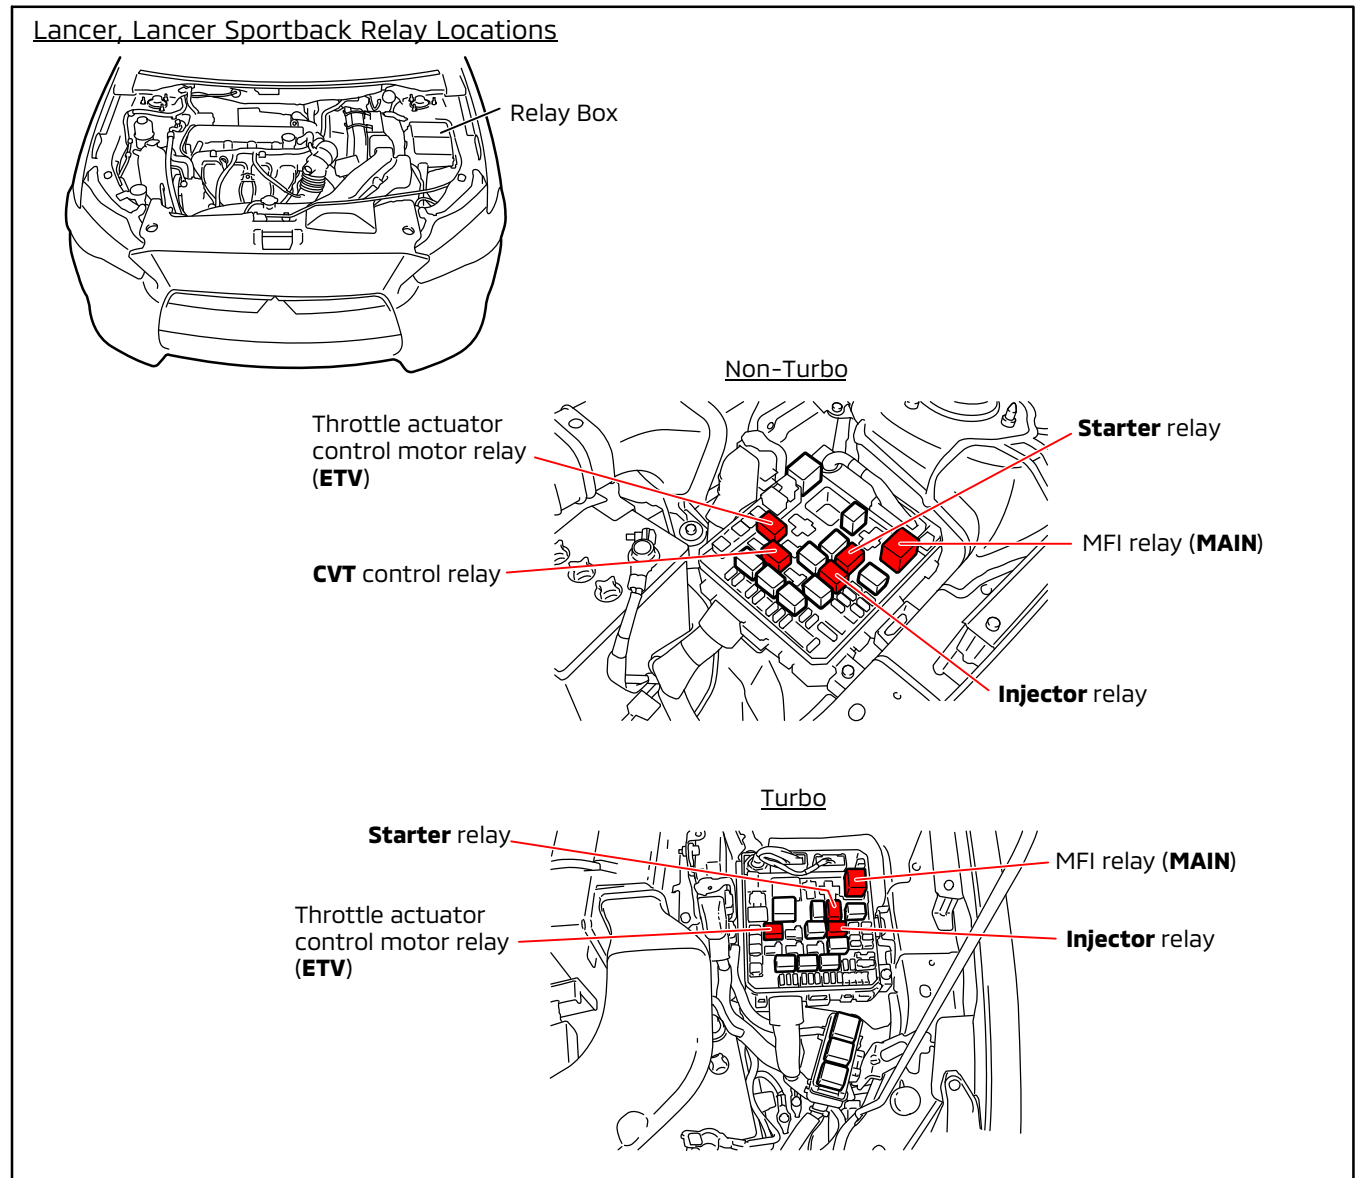
RELAY	DTC	SYSTEM	SYMPTOM
MAIN	U0100	ASC, CVT, ETACS, EPS	Engine does not start
	C1290	ASC	
	P1561	EPS	
ETV	U1417	ASC	Rough idling, no revolution up
	C121C		
	P0657	ENGINE	
A/T (CVT)	U0101	ASC, ETACS, ENGINE	No acceleration, no shifting
	C1290	ASC	
	P1590	ENGINE

If ALL DTCs listed above are present for the systems and vehicles shown, replace the following relays with the anti-freezing type listed below.

RELAYS TO REPLACE	PART NUMBER (anti-freezing type)	PART NAME	RELAY TYPE	QTY
MAIN	8627A050**	RELAY, POWER	Mini ISO	1
ETV	8627A049***		Micro ISO	1
A/T (CVT)*				1
INJECTOR				1
STARTER				1

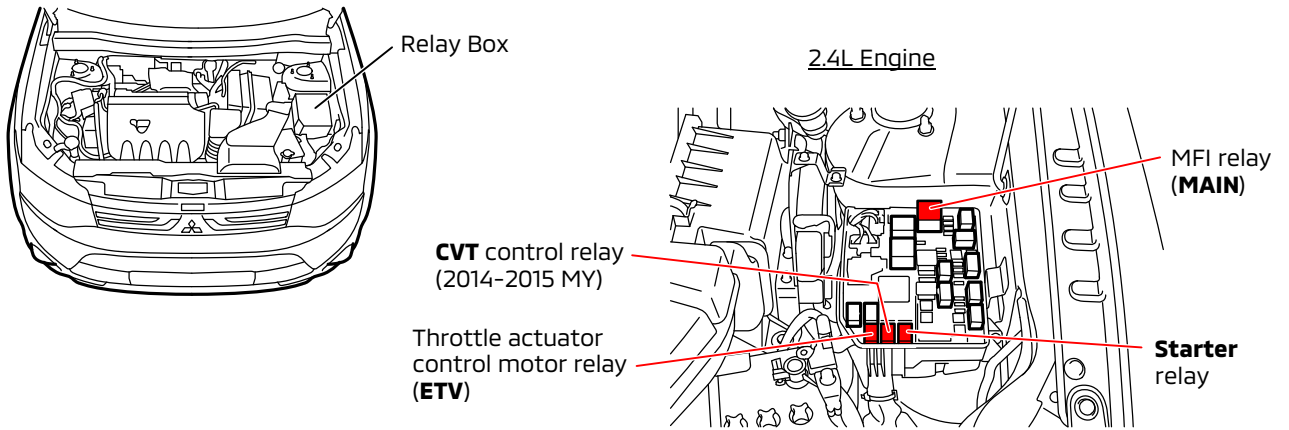
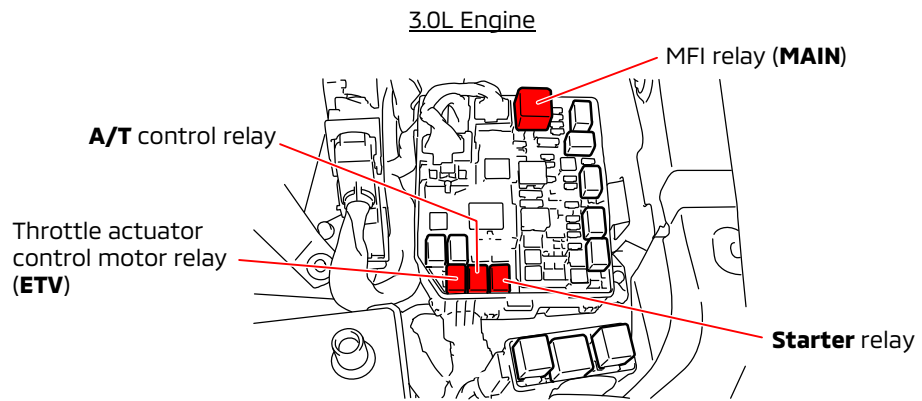
Outlander (2014-2019) Relay Locations

RELAY	DTC	SYSTEM	SYMPTOM
MAIN	U0100	ASC, CVT, ETACS, EPS, AWC	Engine does not start
	B1731*	ETACS	
	P1561	EPS	
	C1632	AWC	
	U15A4	OSS	
	U15A2		
ETV	C121C	ASC	Rough idling, no revolution up
	C1707		
	P0657	ENGINE	
A/T (CVT)	U0101	ASC, ETACS, ENGINE, AWC	No acceleration, no shifting
	P1590	ENGINE	
	C1633	AWC

If ALL DTCs listed above are present for the systems shown, replace the following relays with the anti-freezing type listed below.

RELAYS TO REPLACE	PART NUMBER (anti-freezing type)	PART NAME	RELAY TYPE	QTY
MAIN	8627A050**	RELAY, POWER	Mini ISO	1
ETV	8627A049***		Micro ISO	1
A/T (CVT)*				1
STARTER				1

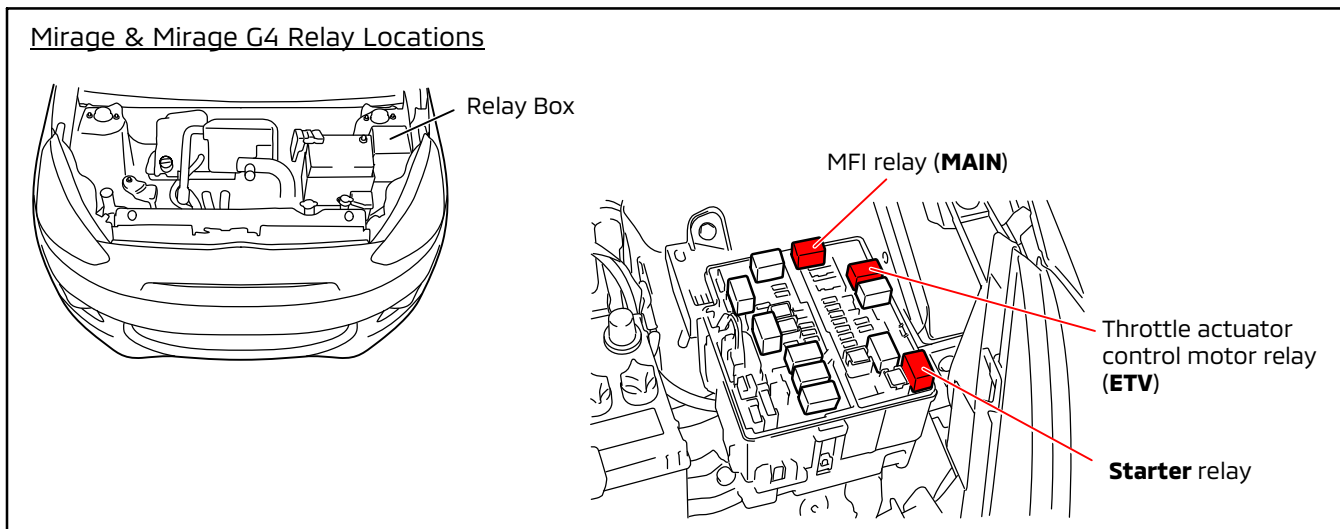
RELAY	DTC	SYSTEM	SYMPTOM
MAIN	U0100	CVT, EPS, KOS/OSS	Engine does not start
	U1100	ASC, ETACS	
	C1560	EPS	
	B1138	KOS/OSS	
	B1731		
ETV	C1396	ASC	Rough idling, no revolution up
	P0657	ENGINE	
STARTER	P1612	ENGINE	Engine does not start
	B1132	KOS/OSS

If ALL DTCs listed above are present for the systems and vehicles shown, replace the following relays with the anti-freezing type listed below.

RELAYS TO REPLACE	PART NUMBER (anti-freezing type)	PART NAME	RELAY TYPE	QTY
MAIN	8627A049*	RELAY, POWER	Micro ISO	1
ETV				1
STARTER				1
