## Repair Notice

**34-074**

Model 520 Pressure Sensor Wiring

4/4/2019

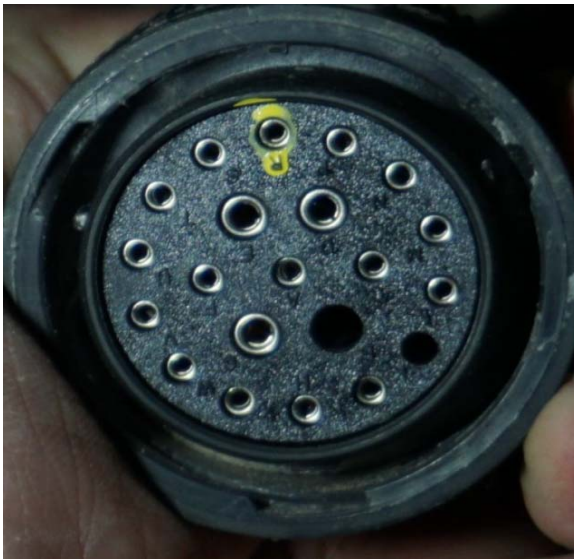
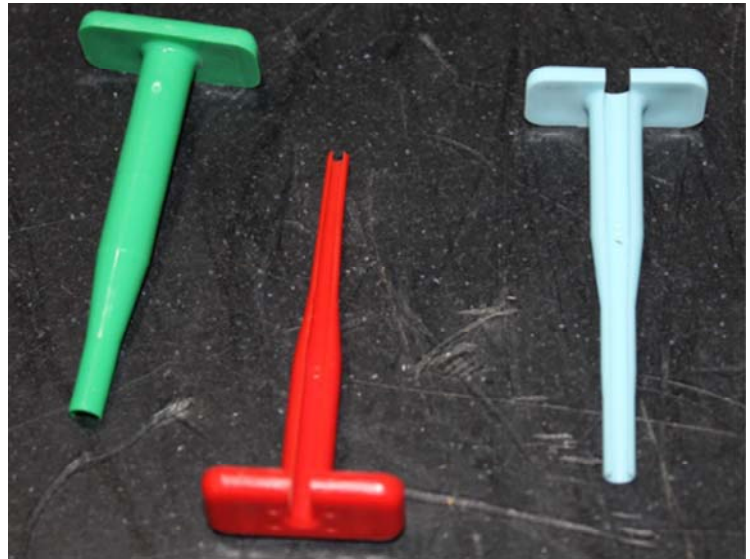
Peterbilt has determined that certain 520 vehicles have a 5 volt supply wire for the air dryer pressure sensor that is no longer required with the current architecture. This wire may result in fault code P1644.

1. Gain access to the connector.
  - Without a stand-up seat, remove the passenger side doghouse panel and locate the connector (could be labeled J015 or J001 - depending on the variation of chassis harness).
  - With a stand-up seat, tilt the cab forward to gain access to connector P521.
2. Locate terminal R and, using the appropriate Deutsch extractor tool, remove the wire from the connector.
