Category Drivetrain

Section Automatic Transmission/Transaxle

Transmission Drivability Concerns

L-SB-0039-18

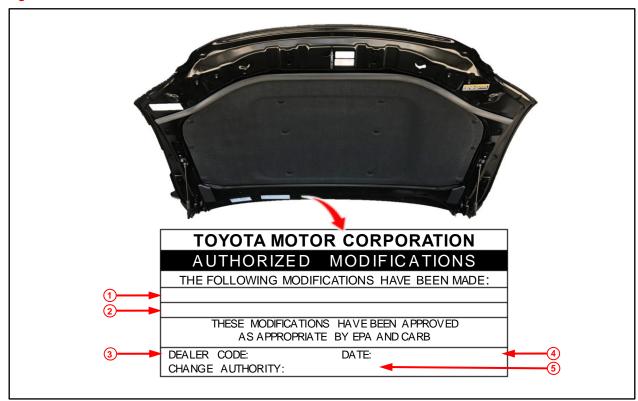
Figure 1. Location of Authorized Modifications Label for 2018 – 2019 LS500

- 2. Use Techstream to confirm if the ECM (PCM) calibration has been updated and check for the Authorized Modifications Label affixed to the vehicle in the location shown below.
 - Is the calibration ID listed in Techstream and on the label the latest ECM (PCM) calibration?
 - YES This bulletin does NOT apply. Continue diagnosis using the applicable Repair Manual.
 - NO Continue to step 3.

- 4. Prepare and install the Authorized Modifications Label.
 - A. Using a permanent marker, enter the following information on the label:
 - ECM part number [Refer to the Parts Information section for the NEW PART NUMBER
 - Calibration ID(s) [Refer to the **Calibration Information** section for the **NEW CALIBRATION ID**
 - **Dealer Code**
 - Repair Date
 - Change Authority [This bulletin number]
 - B. Install the Authorized Modifications Label on the vehicle at the location shown in Figure 1. The Authorized Modifications Label is available through the MDC, P/N 00451-00001-LBL.
- 5. Start the engine and warm it up to normal operating temperature.
- 6. Test-drive the vehicle to confirm proper operation.
