SPECIAL SERVICE CAMPAIGN JOR

INTELLIGENT CLEARANCE SONAR (ICS) SYSTEM REPROGRAM

CERTAIN: 2018 CAMRY & CAMRY HYBRID 2016 – 2018 PRIUS 2017 - 2018 PRIUS PRIME

Update 4/9/2019: Note added on p. 5.

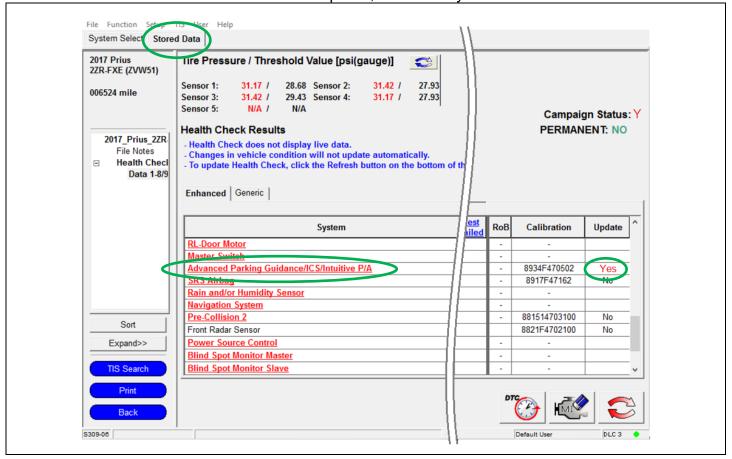
- a. Locate the <u>Update</u> column for the <u>ADVANCED PARKING GUIDANCE/ICS/INTUITIVE P/A</u> ECU in the Stored Data tab for this vehicle.
- b. Determine the status of an available update; indicated by a YES or NO.

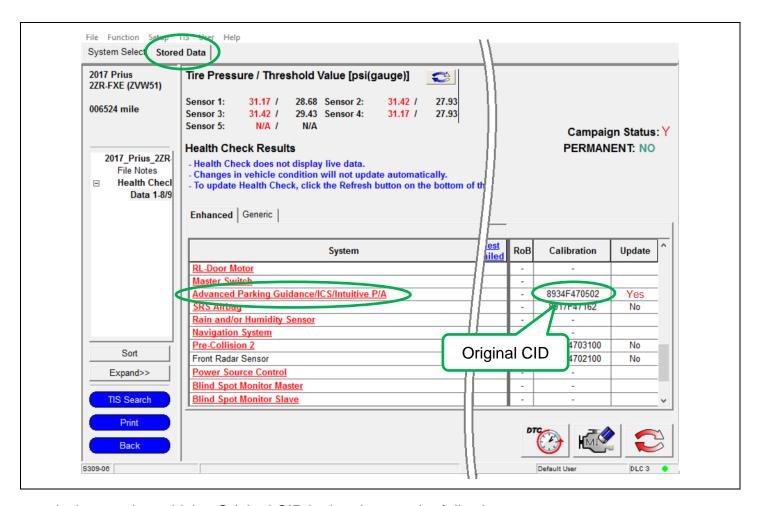
a. Identify the vehicles Original CID for the <u>Advanced Parking Guidance/ICS/Intuitive P/A</u> ECU on the Stored Data tab.

- b. Locate the vehicles <u>Original CID</u> in the chart on the following page.
- c. Select the corresponding NEW CID link to load the update.
- d. Follow the on-screen instructions to complete the ECU re-flash procedure.

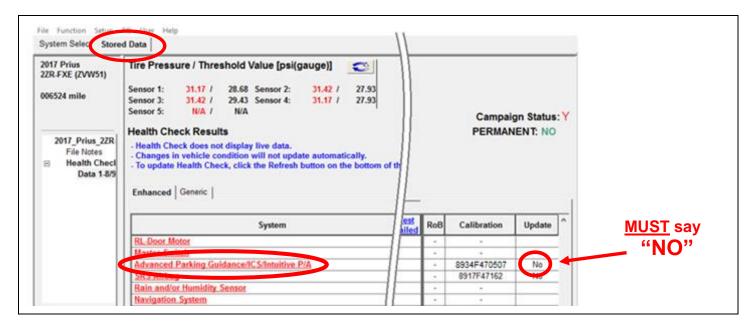
- a. On the Stored Data tab, confirm the following for the Advanced Parking Guidance/ICS/Intuitive P/A ECU:
 - The Update column lists "No"

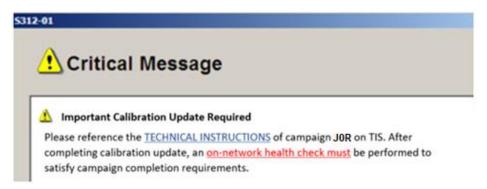
Note: If you receive the following message <u>after</u> the Verification Health Check, you have not properly completed the Required Calibration Updates!!
