VMi TECHNICAL SERVICE BULLETIN (DOC #TS-WI-0421)

VMi Spindle Mount Bracket Replacement for Select Model year Pacifica Minivans

Pacifica Spindle Mount Upgrade

Document Number: TS-WI-0421

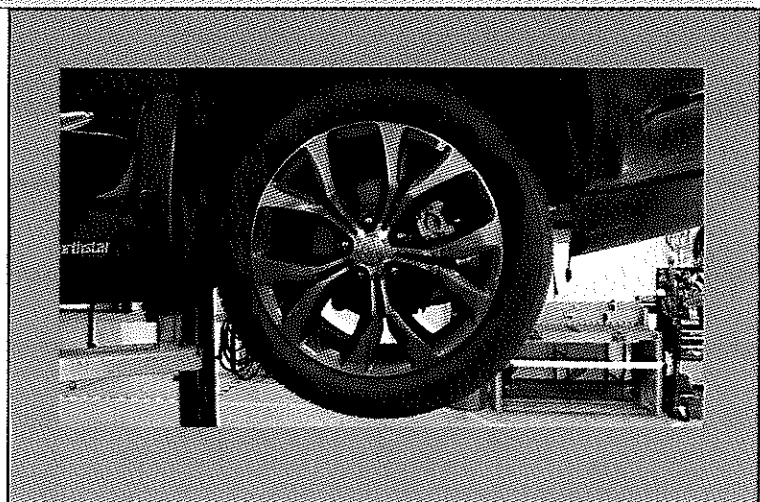
1. Place vehicle on lift and remove both rear tires using a 19mm socket.
2. Inspect Spindle Bracket. If the bracket is NOT a stamped bracket (having rolled inner and outer edges) continue with the replacement.
