**21-19-01 Engine Oil Leak in the Area of Turbocharger Intake Air Hose - Impeller Housing**

Release date: 5/8/2019

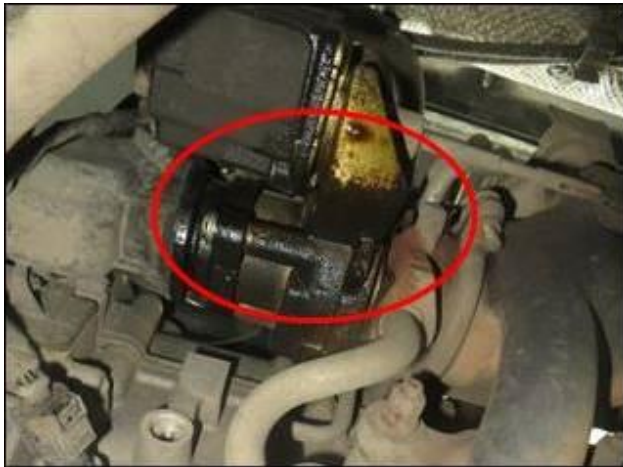
An engine oil leak identified at the Turbocharger and may appear to be leaking from the Turbocharger (Figure 1).

Figure 1: Example of engine oil at the Turbocharger Air Intake Hose.

If engine oil is found in the area of the Turbocharger Air Intake Hose (example Figure 1, red circle):

- Thoroughly clean the impeller housing of the Turbocharger and surrounding components.
- Replace the Turbocharger Air Intake Hose according to the repair manual. See Repair Group 21 in Elsa.

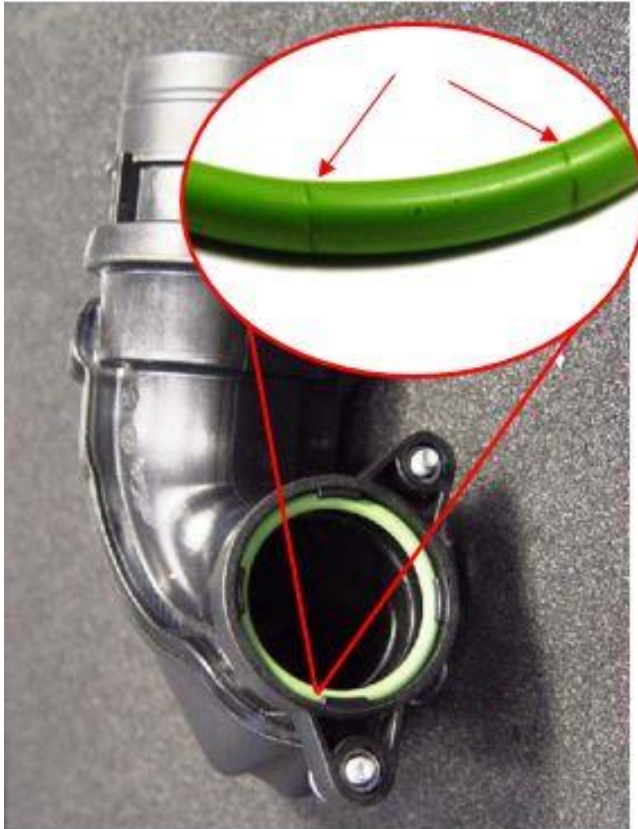
A production-related burr in the Turbocharger Air Intake Hose can lead to imprint damage on the seal (Figure 2).

Figure 2: Example of imprints and damaged seal on Turbocharger Air Intake Hose.

Optimized Turbocharger Air Intake Hose starting with engine number CZTA\_068389.
