Service Bulletin

Bulletin No.: 16-NA-318

Subject: Hard to Steer in Colder Temperatures and/or Knocking/Clicking Noise Heard

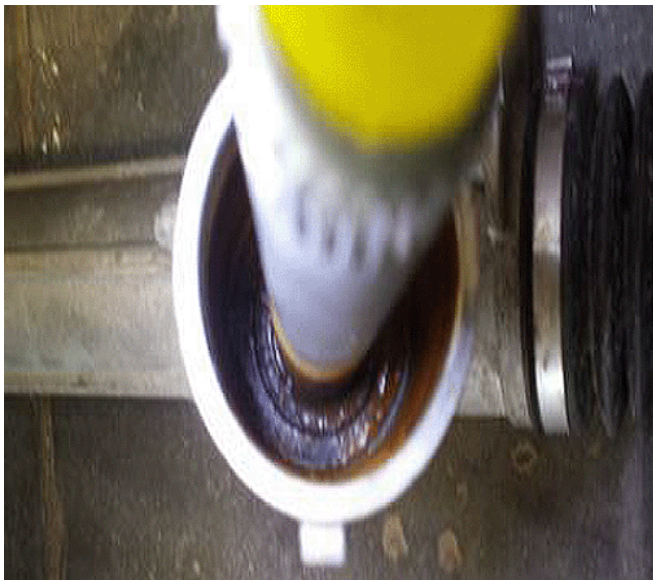
4355408

Check for water intrusion and corrosion at the power steering gear pinion housing. A small amount of rust spots are normal such as one or two small red rust spots.

If water intrusion and/or more than 1 or 2 rust spots is detected, replace both the intermediate steering shaft boots (seals) and the steering gear.
