Service Bulletin

Bulletin No.: 17-NA-166

Date: April, 2019

Subject: Rough Idle in Drive

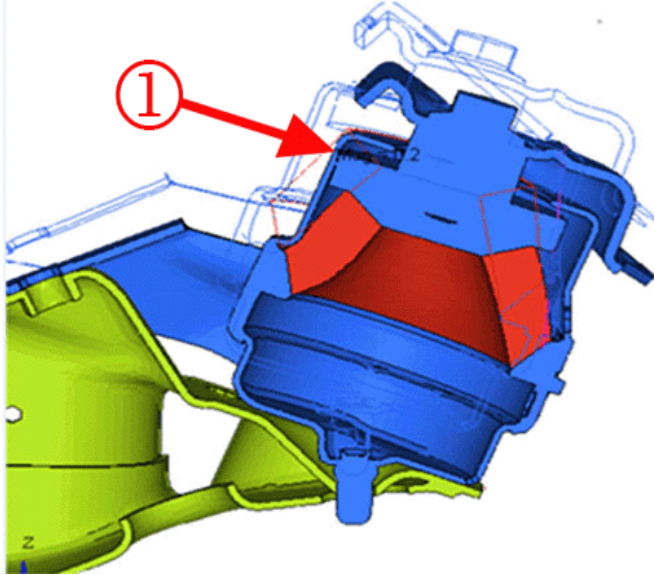
<p style="text-align: right;">4787059</p> <p>This concern may be caused by ground out (1) within one or both engine mounts.</p>
<p>Correction</p>	<p>Important: Familiarize yourself with this entire bulletin before proceeding to ensure you are diagnosing and focusing on the correct issue by frequency measured with Pico scope.</p> <p>Perform PICO analysis, refer to the Service Procedure section below.</p> <p>⇒ If the rough idle / vibration concern frequency is E1.5 in the horizontal / lateral direction with Pico sensor mounted in seat track as indicated below – continue with steps to install updated design engine mounts and settle both engine and trans mounts to reduce amplitude (mg) / eliminate ground out within the engine mounts for vehicles built prior to engine mount breakpoint. For vehicles built after breakpoint, follow Shimming Procedure for Engine Mount Vibration/Grounding after Mount Replacement.</p> <p>Important: The updated engine mounts are designed to reduce internal ground out, primarily E1.5. These mounts along with engine and trans mount settling will typically reduce amplitude at the seat track to 2 mg or less.</p> <p>Note: The 6.2L engine has a characteristic E1 which can be felt, and may be described as a lopey idle. V-8 engine firing frequency produces E4 which will typically be very low frequency at the seat track. Do not confuse 6.2L E1 characteristic (not caused by mount ground-out), with E1.5 normal idle characteristics being transmitted into the truck via ground-out through the engine mounts.</p>

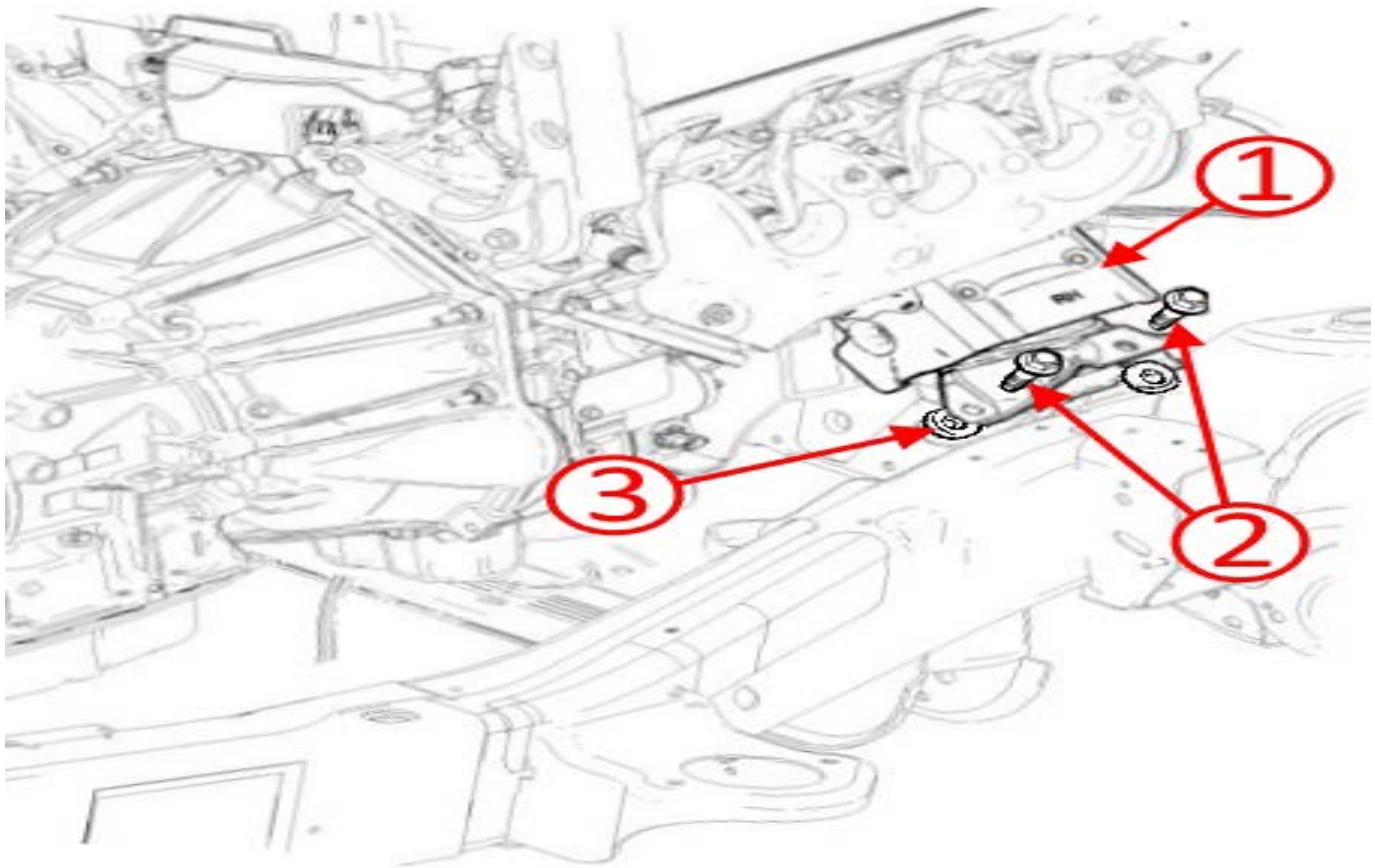
5164611

Note: Idle vibration caused by ground-out within an engine mount may be able to be turned off/on with a single bolt location. Shimming that bolt location may greatly reduce the vibration. In some cases, a combination of bolt location shimming may be needed.

5. Beginning with RH side, loosen the engine mount (1) to frame bolts one at a time a few turns to release clamp load.
6. Remove the position 5 and 6 bolts (2),
7. Utilizing a jack with a block of wood, carefully raise the engine.

Note: For spacer washers mild steel is recommended, no stainless; it may be necessary for some locations to use a small amount of adhesive such as 'dum-dum' to hold spacer in place.

8. If idle vibration was significantly reduced, add a spacer washer (3) approximately 2.5 mm thick between the engine mount and frame at position 5 and 6.
9. Apply threadlocker or equivalent to the threads of the engine mount to frame bolts. Refer to Adhesives, Fluids, Lubricants, and Sealers.
10. Lower the engine.
11. Torque the bolts to specifications to validate if the vibration returns:
 - If idle vibration **could** be turned off with shimming one side, no further work is required.
 - If idle vibration returns. Remove the shims and repeat the process for the LH mount.
