GLOBAL SAFETY FIELD INVESTIGATIONS
DCS5011
URGENT - DISTRIBUTE IMMEDIATELY

Subject: N172097060 - Special Coverage
Side Blind Zone Alert Module Water Intrusion

Models: 2013 - 2016 Chevrolet Cruze
2014 - 2015 Chevrolet Impala
2013 - 2017 GMC Acadia
Equipped with Side Active Safety-Obstacle Detection Enhanced

N172097060 Side Blind Zone Alert Module Water Intrusion

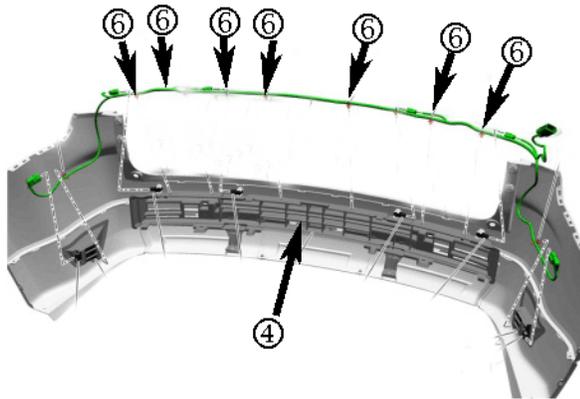
5247740

TIP: If the side object sensors are swollen due to internal corrosion, use warm water to soften the sensor mounting bracket allowing it to flex without damage.

3. Disengage the harness clips (6) from the rear bumper energy absorber (4).

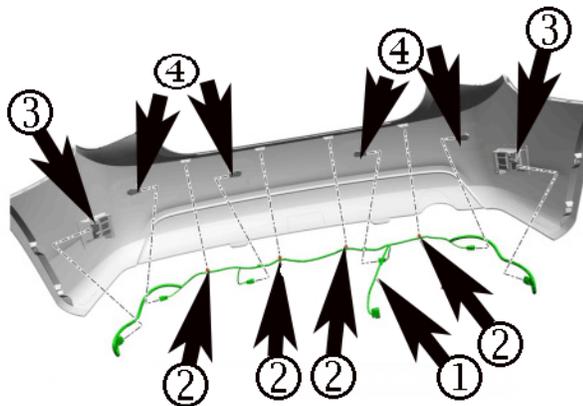
5247877

TIP: If the side object sensors are swollen due to internal corrosion, use warm water to soften the sensor mounting bracket allowing it to flex without damage.

2. Disconnect the electrical connectors from the rear object sensors (4) and the side object sensors (3).
3. Disengage the harness clips (2) and remove the object sensor harness (1) from the rear fascia.

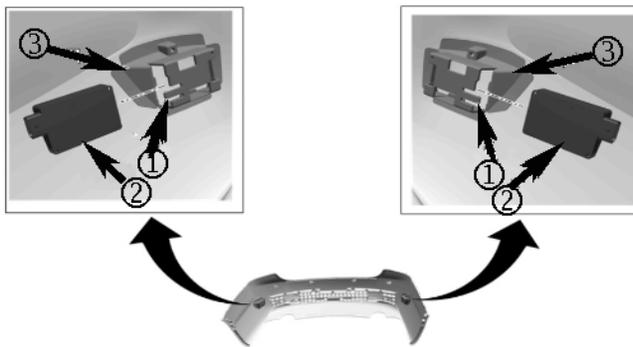
5247913

TIP: If the side object sensors are swollen due to internal corrosion, use warm water to soften the sensor mounting bracket allowing it to flex without damage.

4. Depress the retainer tabs (1) and remove the side object sensor modules (2) from the Module brackets (3).
