GLOBAL SAFETY FIELD INVESTIGATIONS
DCS5019
URGENT - DISTRIBUTE IMMEDIATELY

Subject: N182201851-01 - Service Update
Park Assist Reset
Revised Service Procedure and Warranty Information

Models: 2019 Chevrolet Silverado 1500 (New Model)
2019 GMC Sierra 1500 (New Model)

N182201851 Reset Park Assist

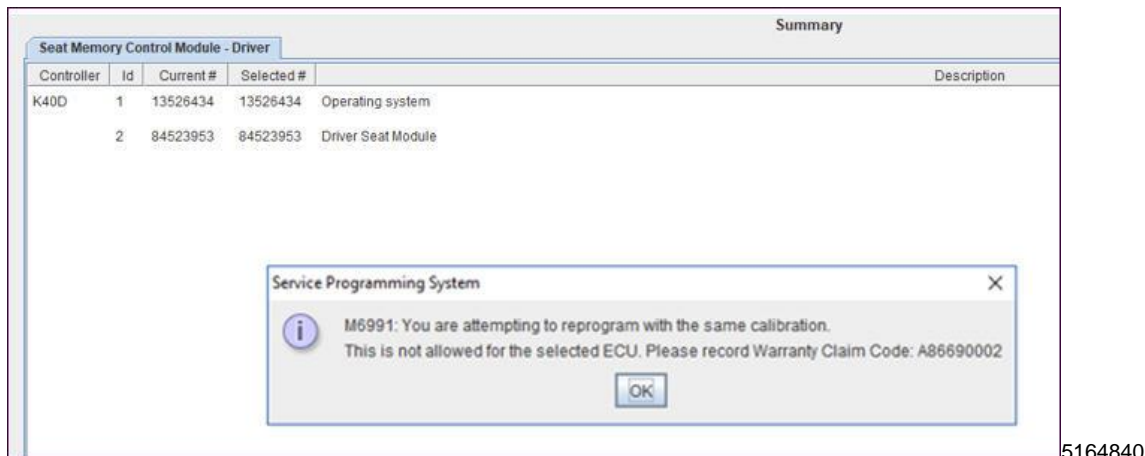
Note: If the Same Calibration/Software Warning is noted on the SPS Summary screen, record the warranty claim code (WCC) and select OK and follow screen instructions. After a successful programming event, the WCC is located in the Service Programming System dialogue box of the SPS Summary screen. No further action is required. Refer to the Warranty section of the bulletin.
