GLOBAL SAFETY FIELD INVESTIGATIONS
DCS5023
URGENT - DISTRIBUTE IMMEDIATELY

Subject: N192211320 - Service Update
Left Front Lower Control Arm Ball Joint Not Seated

Models: 2019 Buick Enclave
2019 Chevrolet Traverse

N192211320 Left Front Lower Control Arm Ball Joint Not Seated

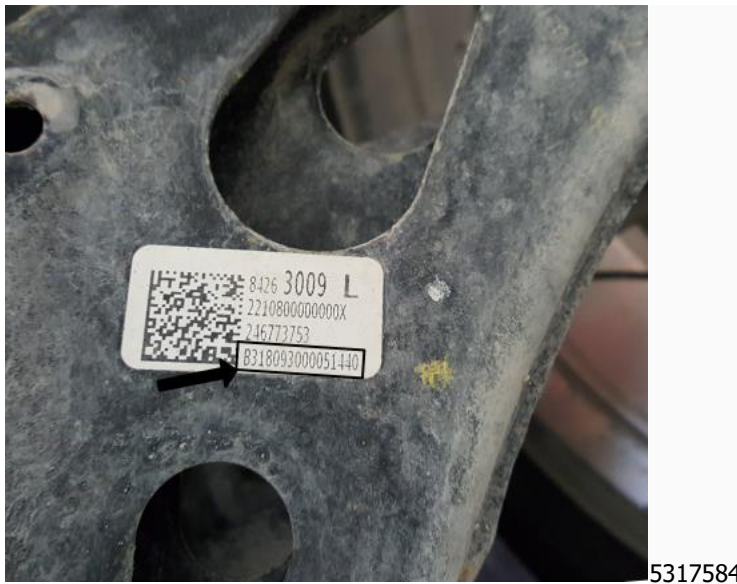
Condition	Certain 2019 model year Buick Enclave and Chevrolet Traverse vehicles may have a left front lower control arm ball joint not fully seated.
Correction	Dealers are to inspect the label on the left front lower control arm for suspect serial numbers and replace the left front lower control arm if it matches the suspect list.

2. Inspect the left front control arm label serial number as shown here. Using the find function in windows (Ctrl+F) search this bulletin to see if the control arm serial number on the vehicle matches a serial number listed in this field action.
 - If the serial number does NOT match a serial number found in this field action, no further action is required. Proceed to step 3.
 - If the serial number of the control arm on the vehicle matches a serial number in this field action (or if the serial number on the label is illegible), replace the control arm. Refer to *Lower Control Arm Replacement* in SI.
3. Lower the vehicle. Refer to *Lifting and Jacking the Vehicle* in SI.
