HYUNDAI

Technical Service Bulletin

GROUP HYBRID CONTROL	NUMBER 19-HC-001H
DATE APRIL 2019	MODEL SONATA HYBRID/ PLUG-IN HYBRID (LF HEV/PHEV)

SUBJECT: AUTOMATIC TRANSAXLE
DTC P1990, P1B76, P1B77 & P0A0D

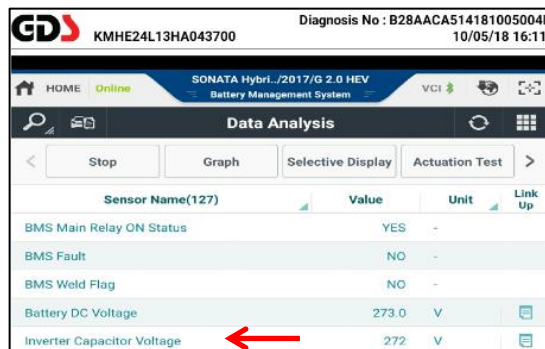
Attach a GDS and select **Data Analysis** and **BMS** menu and the parameters shown below.

All the parameters should indicate as shown below.

If the **Inverter Capacitor Voltage** is:

- 200v~310v: the voltage is currently within specification. Go to Step 3 and replace the PRA.
- Less than 200v. Go to Step 3. Follow the diagnosis for the PRA fuse in Step 7.
