# Service Bulletin

Bulletin No.: 17-NA-221

**Subject:** Poor Engine Performance in Extremely Cold Weather Conditions for LE2 Engines, Charge Air Cooler Icing - Malfunction Indicator Lamp (MIL) Illuminated, DTC P0299, P0236, P2227, P00C7 Set

Brand:	Model:	Model Year:		VIN:		Engine:	Transmission:
		from	to	from	to		
Buick	Encore	2016	2019	SOP	September 18, 2017	Equipped with 1.4L (RPO LE2)

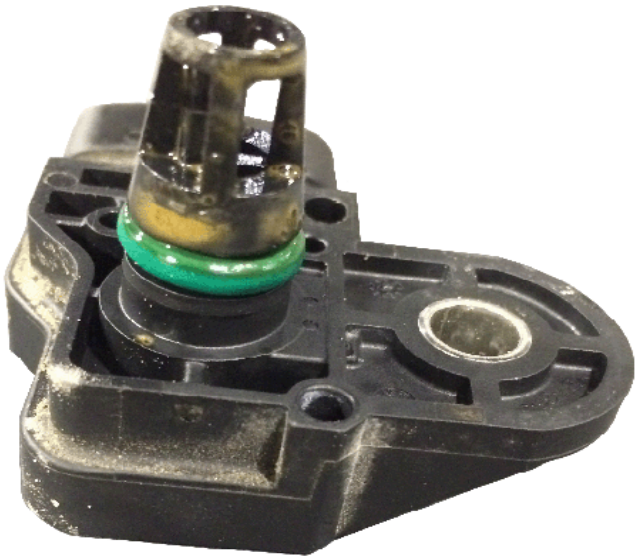
4910683

2. Inspect the sensor for any contaminants.

**Important:** Due to the sensitivity of the sensor, **Do Not** use any chemical cleaners including water and **Do Not** use compressed air to remove contaminants.
