Service Bulletin

Bulletin No.: 17-NA-231

Subject: Information on the Replacement of the Video Processing Module Due to Water Intrusion

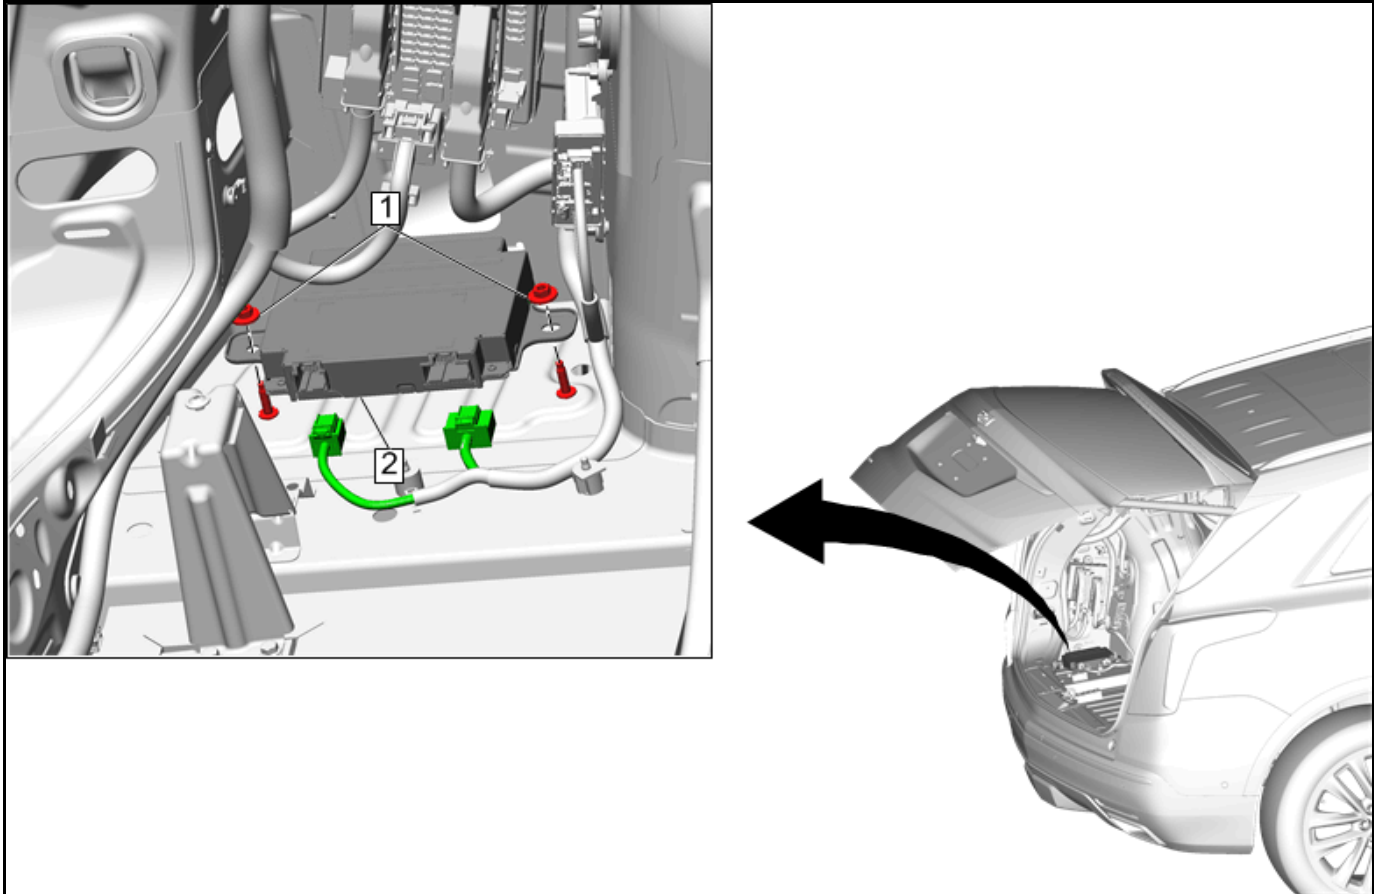
4291116

Involved Region or Country	North America, Europe, Middle East and N.A. Export Regions
Additional Options (RPOs)	Equipped with 360 View Camera (RPO UVH)
Condition	During diagnosis, a technician may find that water intrusion caused a malfunction within the Video Processing Module.
Correction	Verify the condition, then remove and replace the Video Processing Module and install two flat washers per mounting stud.

2. Install 2 washers for each stud used to mount the video processing unit.

Note: Be sure to install the washers under the video processing unit, so that the unit is raised from the installation of the washers.
