# Service Bulletin

Bulletin No.: 17-NA-256

**Subject:** Information on Trailer Brake Controller Blunt End Harness Breakout Connection

Brand:	Model:	Model Year:		VIN:		Engine:	Transmission:
		from	to	from	to		
Buick	Enclave	2018	2019				
Chevrolet	Traverse

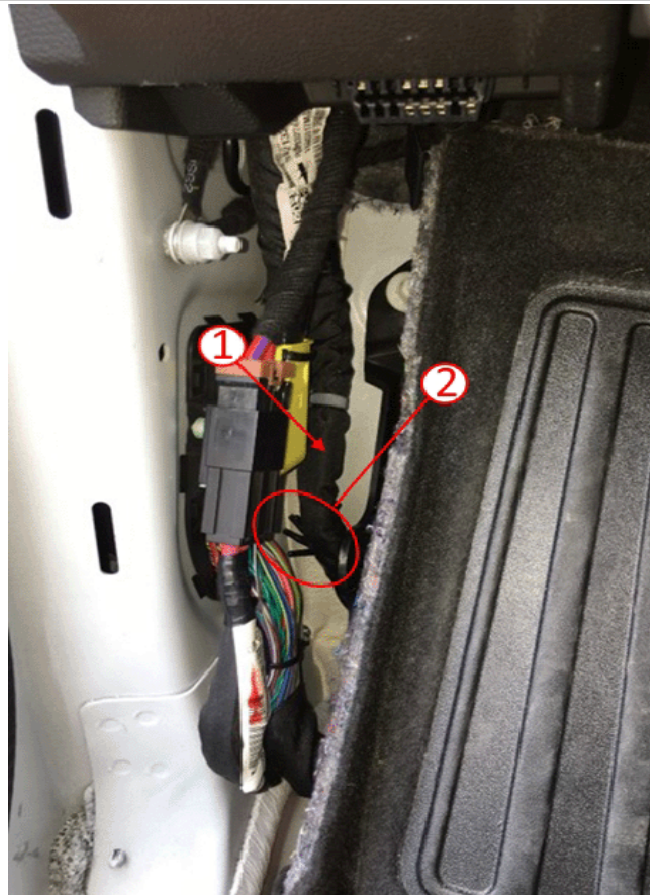
4847349

<b>Involved Region or Country</b>	North America, Russia, Middle East, Israel, Colombia, Chili, Peru and Africa
<b>Additional RPO's</b>	V92
<b>Condition</b>	The customer may not be able to find the location of the integrated wiring harness used for implementing a trailer brake controller to the vehicle.

The trailer brake controller blunt ends (2) is part of the Instrument panel wiring harness and the blunt cut wires are located under the left instrument panel, behind the front side door sill garnish molding trim.

If the customer wishes to have an aftermarket brake controller installed in their vehicle, it would be considered as a Customer Pay option.
