# Service Bulletin

Bulletin No.: 18-NA-136

**Subject:** Rattle, Loose Lumber Type Noise or Popping/Clunking Type Noise Coming from Rear Suspension

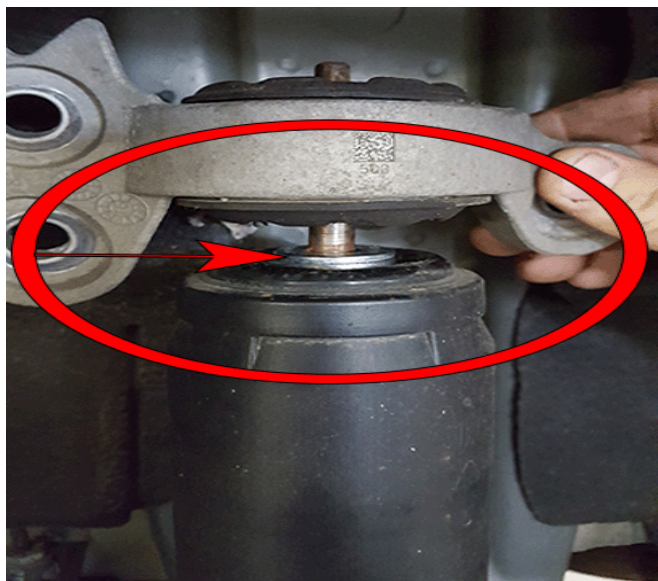
5046813

**Note:** This will prevent contact of the shock to the rubber of the shock mount.

5. Install a washer on the rear shock absorber as shown above.
6. Reinstall the shock into the shock mount and tighten the nut.

Tighten the nut to 20 N•m (15 lb ft).
