Service Bulletin

Bulletin No.: 18-NA-301

Subject: Service 4WD Lamp Message Displayed - DTC C119B 04, P0700, and/or P2534 Set

Brand: Model:	Modeli	Model Year:		VIN:		Engine:	Transmission:
	woder.	from	to	from	to		
Chevrolet	Silverado 1500 (New Model)	2019	2019			L84, L87	
GMC	Sierra 1500 (New Model)					·

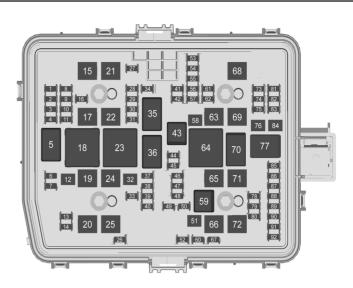
4698775

Involved Region or Country	North America, Middle East, South America, North Africa and Thailand (ASEAN).	
Additional Options (RPOs)	F48 , NPO and NQH.	
Condition	Some customers may comment that the Service 4WD light is on. Some technicians may find one or more of the following DTC's set: C119B 04: Front Axle Engagement Feedback Switch Circuit set in the TCM P0700: Transmission Control Module Requested MIL Illumination P2534: Ignition On/Start Switch Circuit Low Voltage set in the ECM	
Cause	This condition may be caused by the front axle actuator pulling over 5 amps, blowing the fuse.

Locate fuse #47 and/or #83 in the Front Compartment Fuse Block. Refer to Document ID: 4694932 in SI.

- Replace fuse #47: Transmission control module ignition with a 10A fuse.
- Replace fuse #83: FTZM with 30A fuse.
- · Install new fuse block cover.
- New cover reflects the changes to the fuses for two circuits.
