Service Bulletin

Bulletin No.: 18-NA-377

Subject: Front Seat Lateral Movement and/or Click Type Noise While Driving

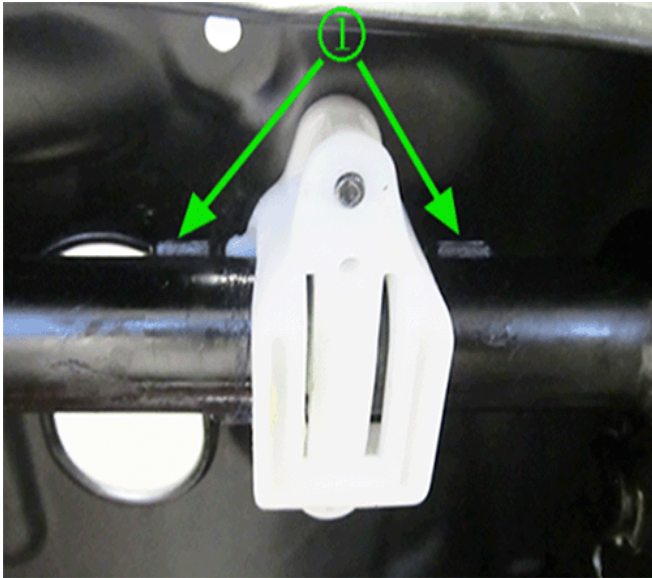
4649728

Note: For some 2016 and newer model years, an updated seat frame design incorporates welded brackets (1) to the seat frame pivot bar, on each side of the white guide block. This helps to reduce the excessive lateral seat movement.

Important: Regardless of the model year, in some cases, even with the updated seat frame design, there still could be excessive clearance between the welded brackets (1) and the white guide block. This will cause excessive lateral seat movement.

9. If the excessive lateral seat movement is verified, the front seat lateral retainer (GM PN 13405675) can be installed to correct this condition.

Important: The installation procedure of the lateral retainer, will depend on which seat frame design the vehicle has. In order to be able to correctly install the front seat lateral retainer on the new updated seat frame design, a modification **MUST** be done.

10. Inspect the seat frame for existence of the added welded brackets (1):
 - If **NO** welded brackets are visible on the seat frame, jump ahead to step #12 and install the lateral retainer.
 - If the welded brackets are visible on the seat frame, continue on to step #11, which includes a modification step.
