## **Service Bulletin**

Bulletin No.: 19-NA-008

Subject: Upper Inboard Corner of the Rear Body Structure Stop Lamp Has Sharp Edge

Brand:	Model:	Model Year:		VIN:		Engine:	Transmission:
Biallu.		from	to	from	to		
GMC	Acadia (VIN N)	2017	2019			All	All
	Terrain	2018	2019

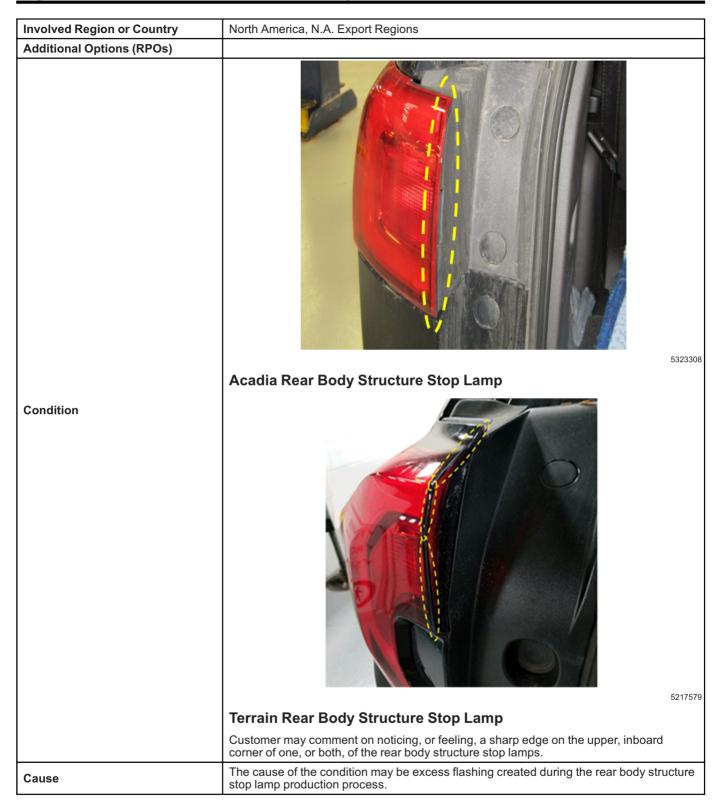
5217582

Raise the rear liftgate and inspect both stop lamps for excess material (flash) at the parting line on the existing lamp, at the location shown above.

If sharp edge if verified, using 400–600 grit sandpaper, lightly sand the sharp edge to a smooth roundness.
