Service Bulletin

Bulletin No.: 19-NA-035

Subject: 8L45, 8L90 Park System Does Not Engage

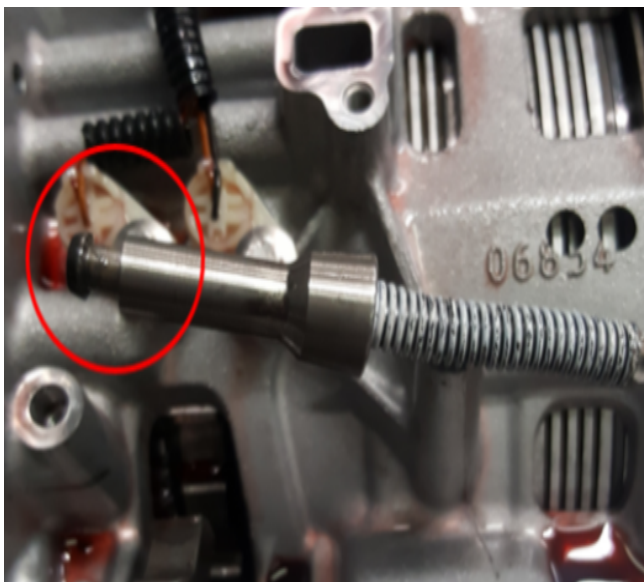
5247414

7. Inspect for damage, bent rod or incomplete travel of the actuator.

⇒ If damage to the Park Pawl Actuator and Park Pawl is present as described above, replace the following components:

- Park Pawl Actuator
- Park Pawl
- Main Shaft Detent Lever Hub Pin
- Park Pawl Actuator Bracket
- Park Pawl Actuator Bracket Bolts
- Output Carrier

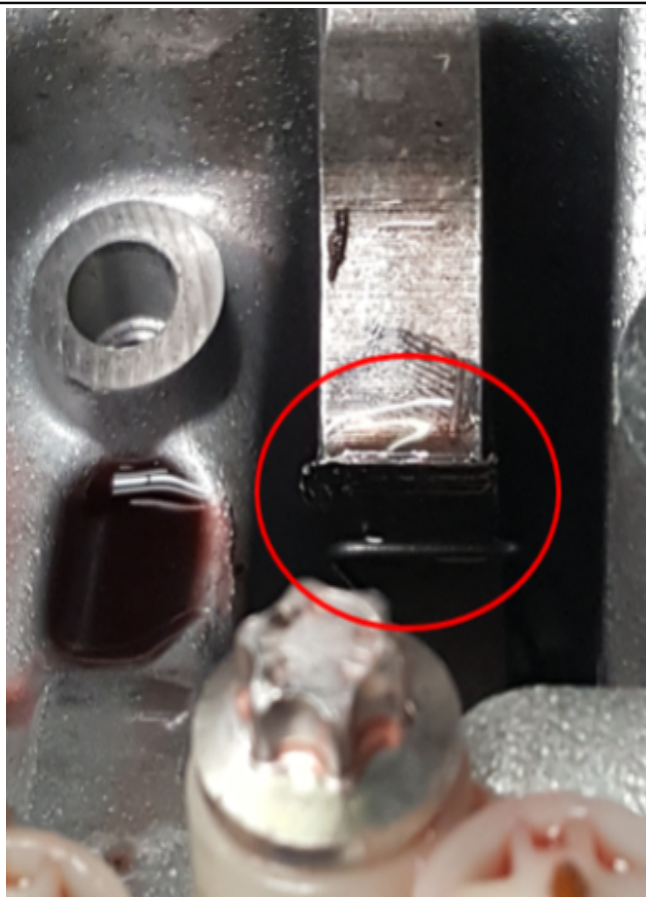
5247435

8. Inspect the park pawl for damage.
