Service Bulletin

Bulletin No.: 19-NA-040

Subject: Radio Screen Flickering when On

Brand:	Model:	Model Year:		VIN:		Engine:	Transmission:
		from	to	from	to		
Chevrolet	Volt	2019	2019			All	All

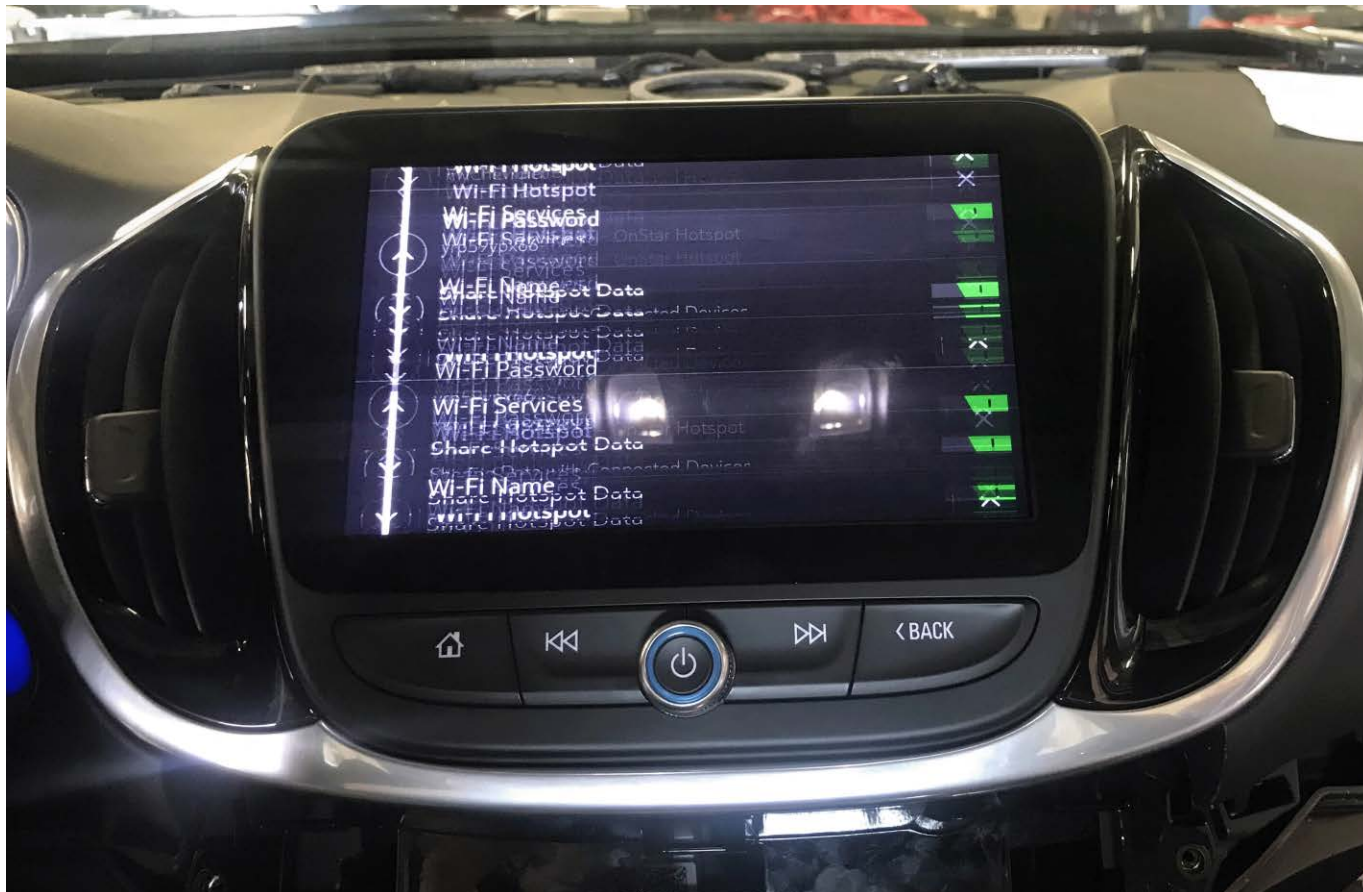
5246376

An example of possible screen flickering. If screen flickering is experienced, then the wiring harness behind the radio needs to be rerouted and held with zip ties.

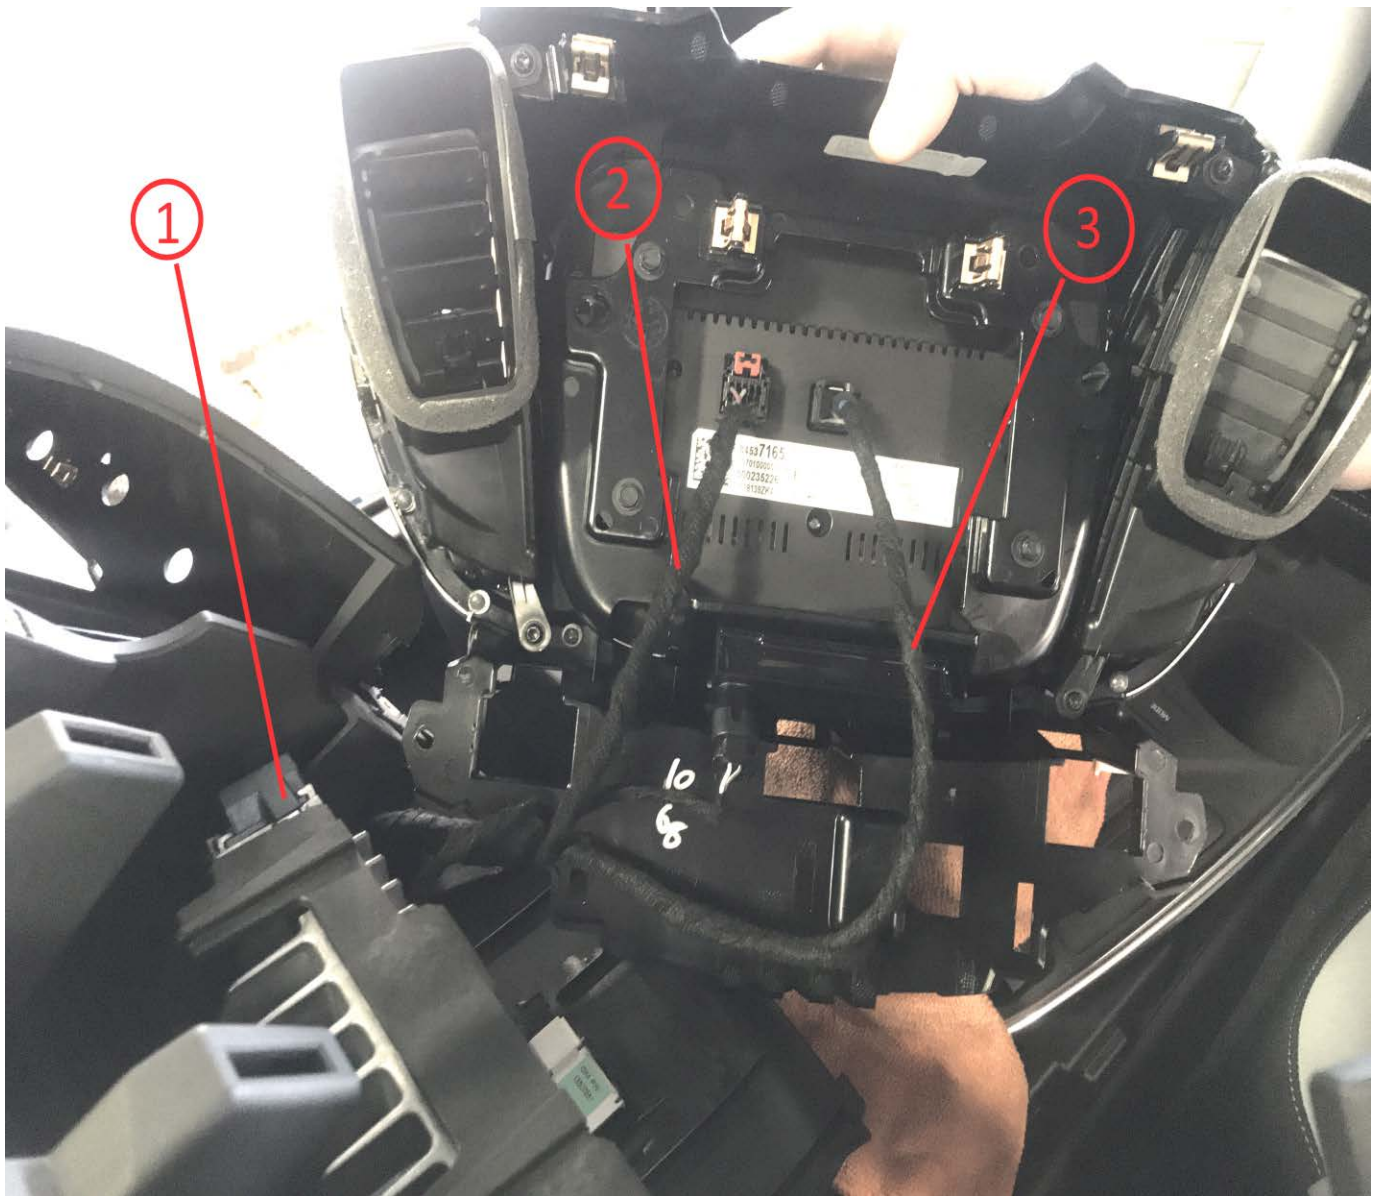
5246390

Example of back of the radio before rerouting the wires

1. WiFi Antenna
2. Branch Integrated Center Stack (ICS)-Power cable
3. Branch Low Voltage Differential Signaling (LVDS) cable
