Service Bulletin

Bulletin No.: 19-NA-047

Subject: Radio Software Version V803 Over-the-Air Update

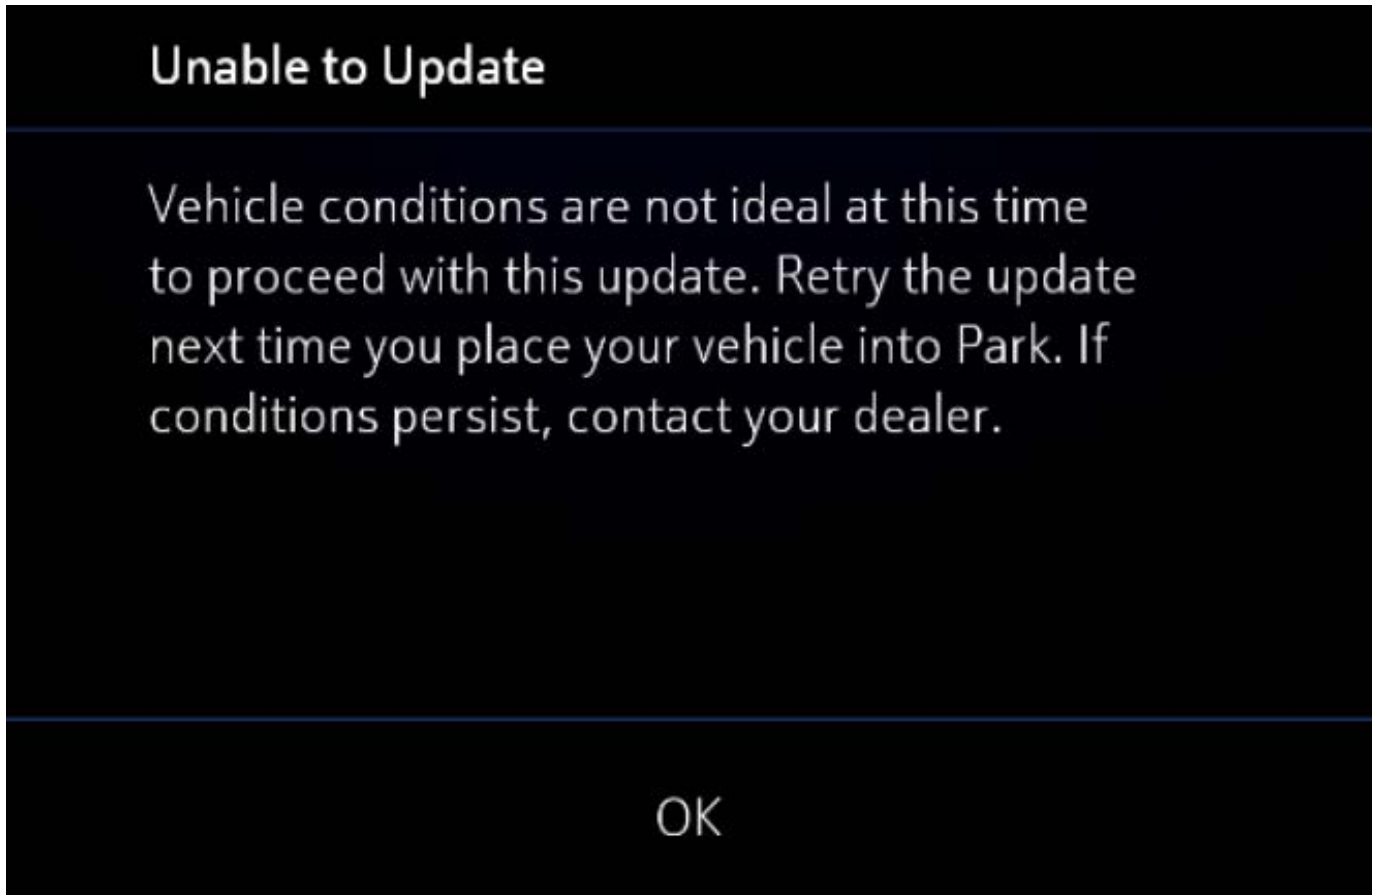
5258745

Scenario 1: Vehicle conditions are not ideal.

If the above screen is shown, download the update through TIS2Web and perform USB update. Upon USB insertion while vehicle is running, the "Install Now" pop up will be presented. Ensure the vehicle battery is being maintained (using EL-49642 or battery maintainer) while performing this update.

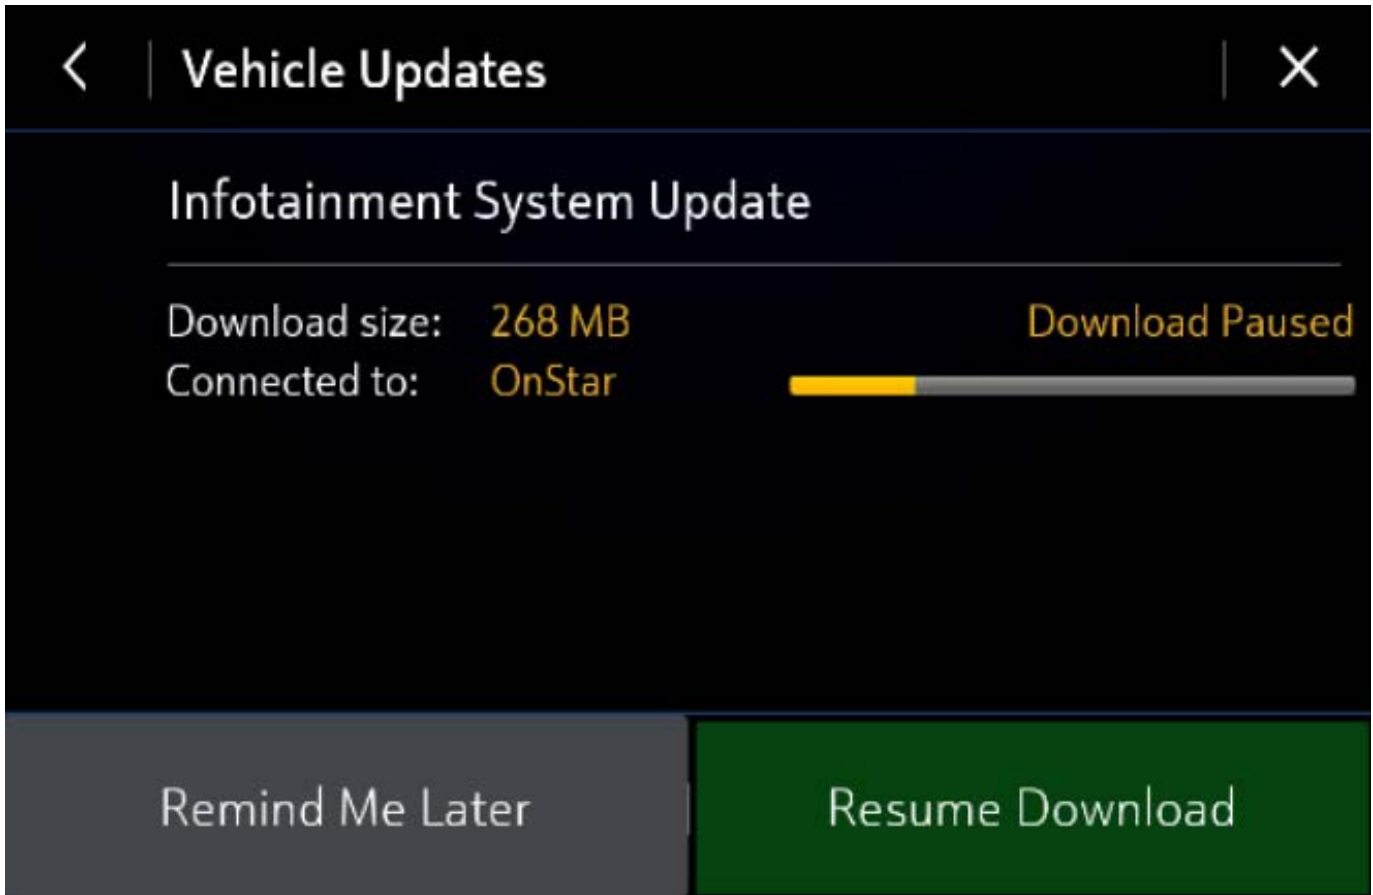
5258747

Scenario 2: Consistently Paused Download

If the above screen is shown and resuming the download repeatedly fails, a USB update will need to be performed. Turn the vehicle on, return to the home screen, and insert USB stick (see previous section). A pop up should be shown to "Install Now." Click "Install Now", verify the part number is correct and follow on screen prompts.

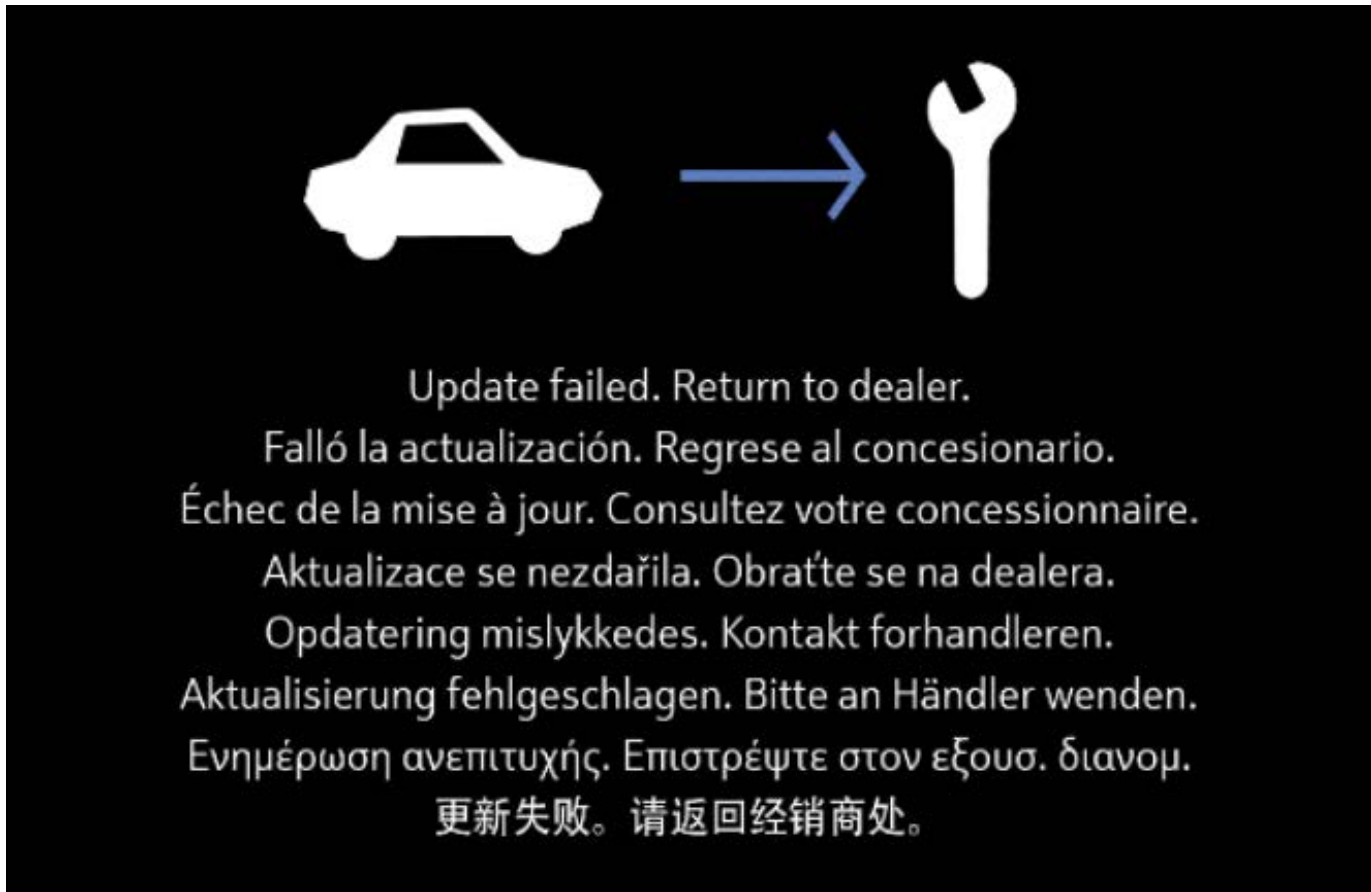
5258748

Scenario 3: Update Failed. Return to dealer screen.

1. If the above screen is shown, download the update through TIS2Web and insert USB stick into the radio **twice** (USB stick is not recognized on first insertion). A blue progress bar should come on the screen and update will proceed. If this screen above is shown when trying to update the radio through USB, reformat to FAT32 on your PC, and then try to download the update through TIS2WEB again.
2. After selecting USB File Transfer, if you are prompted by TIS2Web to select a software PN then follow the on-screen instruction to attempt to gather the software PN from the A11 Radio using GDS2 scan tool. If GDS2 indicates the radio is not communicating, go back to TIS2Web, select A11 Radio, and select "Per Bulletin **19-NA-047** " to complete the USB File Transfer programming event.
3. If the screen above is shown again, contact Technical Assistance (TAC) for further assistance.
