Service Bulletin

Bulletin No.: 19-NA-065

Subject: Pop Noise From Fuel Tank After a Cold Start or EVAP Purge Event

Brand:	Model:	Model Year:		VIN:		Engine:	Transmission:
		from	to	from	to		
Chevrolet	Equinox	2010	2017				
GMC	Terrain

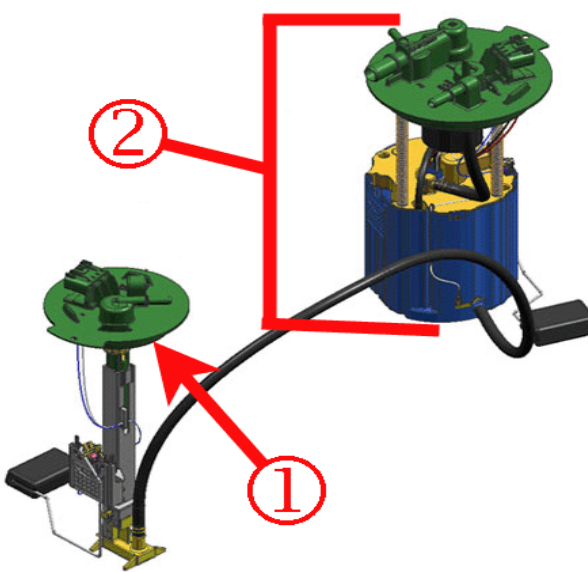
3723460

</div> <p>Important: The condition described in this PI applies only to the auxiliary fuel pump module assembly. The Parts Catalog calls this auxiliary pump component (1) the "Fuel Pump Auxiliary" which is the correct part for this repair. Replacing the primary fuel pump module (2) assembly would NOT correct this noise condition. The parts catalog calls this primary pump component the "Fuel Pump" which is the incorrect part for this repair.</p> <p>The technician should be able to duplicate the concern by commanding a purge and seal on the EVAP system using GDS2.</p> <p>⇒ As the vacuum reaches 3 – 5 inches Hg (17 kPa), the pop/popping noise should be duplicated.</p>

Refer to Fuel Tank Fuel Pump Module Replacement in SI.
