# Service Bulletin

Bulletin No.: 19-NA-068

**Subject: Malfunction Indicator Lamp (MIL) Illuminated, Intermittent Service Messages - DTC's U0073, U0121, U0100 and/or U0101 Set, G103 Inspection**

Brand:	Model:	Model Year:		VIN:		Engine:	Transmission:
		from	to	from	to		
Chevrolet	TRAX	2015	2019			All	All
Holden	Trax	2015	2019

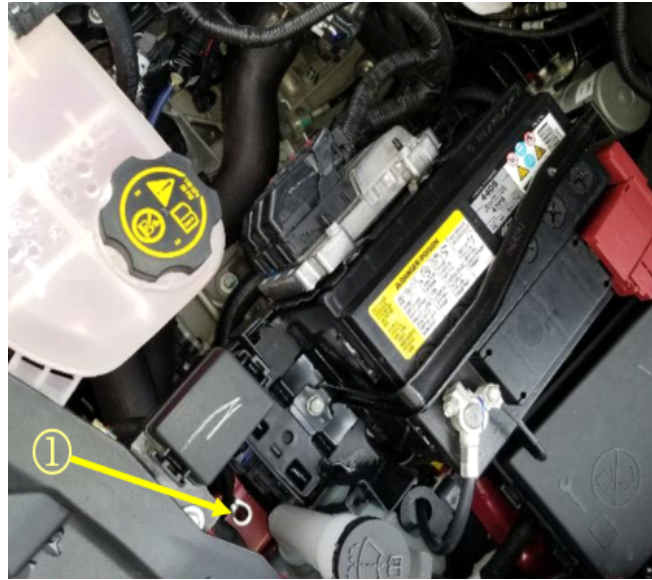
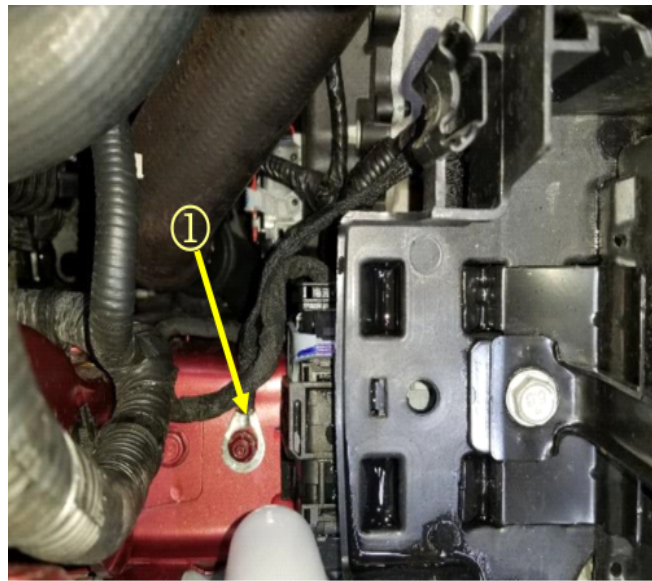
The cause of the condition may be a poor ground connection at G103 (1), located at the left front frame rail in front of the battery.
