Solution K94743326

Title Diagnostic Trouble Code (DTC) P009B-13 Fuel Pressure Relief Control – Circuit Open;  
Possible Derate - US17+OBD16 And US17+OBD18 Emissions, Model Years 2018  
And 2019

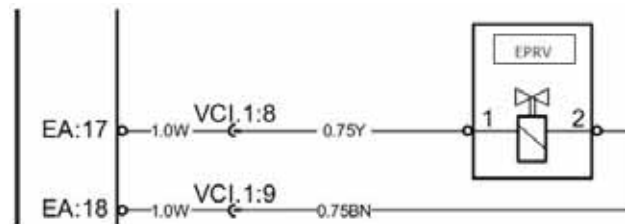
1. Visually inspect wiring, connectors, pins, terminals, etc. from Engine Control Module (EMS) Connector EA (Pins 17 & 18) through the VCI Connector (Pins 8 & 9), to the connector at the ERPV.

- **If an open circuit or high resistance is found:** Make necessary repairs.
- **If no issues are identified:** Replace the ERPV and the front internal engine harness.
- **For all repairs:** Apply Permatex Dielectric Grease part no. 81150 or 22058 to the pin and socket terminals of the ERPV and harness connector. The grease may be sourced locally.
