HYUNDAI Technical Service Bulletin	GROUP	NUMBER
	CAMPAIGN	19-01-009H
	DATE	MODEL(S)
	APRIL 2019	VELOSTER (FS)
SUBJECT: VELOSTER VACUUM PUMP SEALANT APPLICATION / CAP REPLACEMENT (SERVICE CAMPAIGN T3F)

This TSB supersedes TSB# 18-01-031 and modifies the Service Procedure.

Description: Some subject vehicles may experience the illumination of various warning lamps including the brake warning lamp and other lamps. This bulletin describes the procedure to apply sealant to the vacuum pump or replace the vacuum pump cap based on vehicle inspection.

Applicable Vehicles: Certain 2015-2017 MY Veloster (FS) vehicles with 1.6L Turbo engines

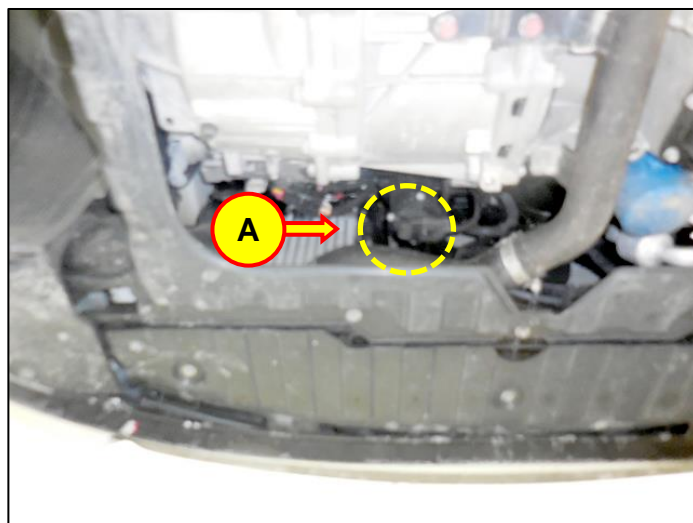
1. Check the vehicle's dashboard for any warning lights (refer to notice below). Lift up the vehicle and find the electronic vacuum pump (A).

Check the vehicle's dashboard for any warning lights. If any warning lights are present, the vacuum pump cap will be replaced.

If no warning lights are present, sealant will be applied to the vacuum pump.
