HYUNDAI Technical Service Bulletin	GROUP	NUMBER
	CAMPAIGN	19-01-010H
	DATE	MODEL(S)
	APRIL 2019	TUCSON (TL)
SUBJECT: TUCSON VACUUM PUMP SEALANT APPLICATION / CAP REPLACEMENT (SERVICE CAMPAIGN T3C)

This TSB supersedes TSB# 18-01-026 and modifies the Service Procedure.

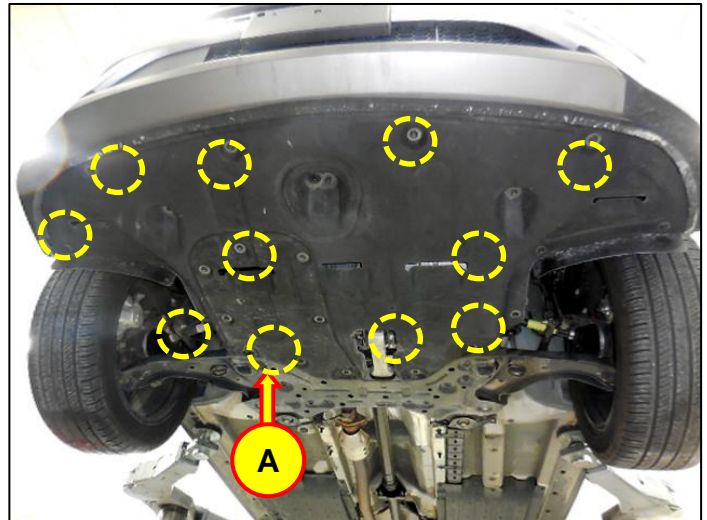
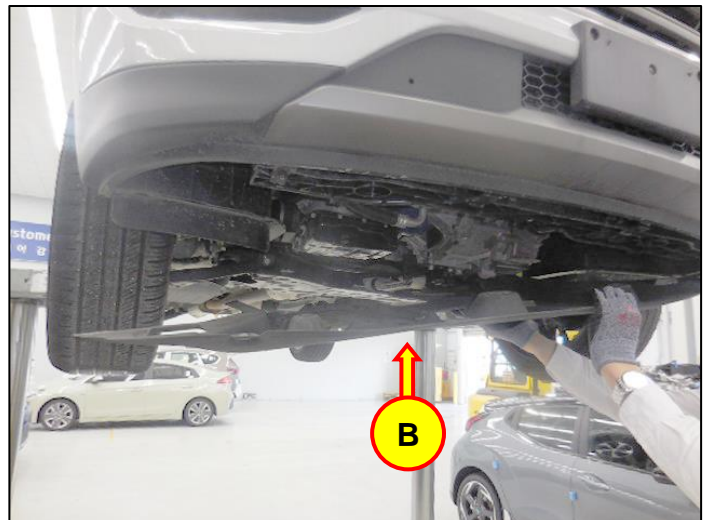
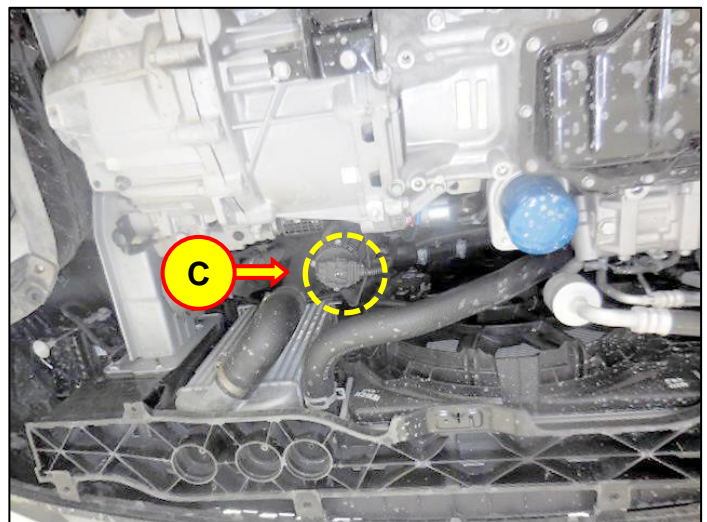
1. Check the vehicle's dashboard for any warning lights (refer to notice below). Lift up the vehicle and loosen the engine under cover mounting bolts (A).

2. Remove the engine under cover (B).

3. Check the position of the electronic vacuum pump (C).
