# SERVICE BULLETIN

Classification: BT19-002	Reference: NTB19-034	Date: April 16, 2019
-----------------------------	-------------------------	-------------------------

## 2018-2019 TITAN XD; WHISTLE NOISE FROM VEHICLE FRONT AT 60 MPH AND ABOVE

**APPLIED VEHICLES:** 2018-2019 Titan XD (A61)

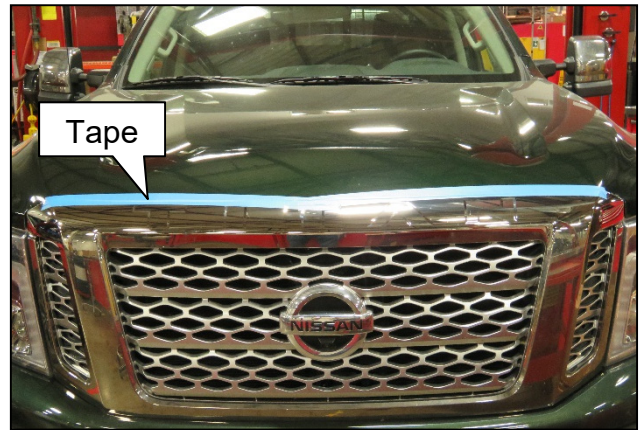
Figure 1

A whistle type noise heard from the vehicle front at speeds of 60 MPH and above.

1. Apply painters tape over the gap between the grille and hood as shown in Figure 1.

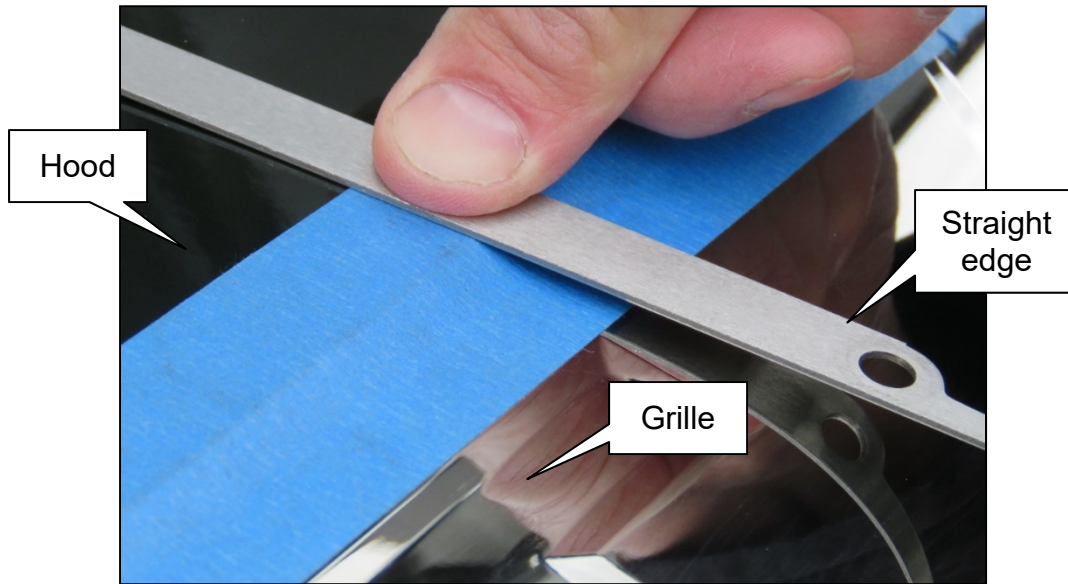
Figure 4

b. In Figure 4, the hood is over flush with the grille. In this situation, apply finger pressure on the straight edge near the front edge of the hood as shown. If the hood is under flush with the grille, apply finger pressure on the straight edge near the rear edge of the grille.

a. Place a straight edge near the center of the grille as shown in Figure 4.

- d. Measure the thickness of the straight edge.
- e. Subtract the thickness measurement of the straight edge from the measurement taken in step 11c.
- f. Adjust the hood using the hood latch if the measurement at the center is more than 0.4 mm over flush or more than 3.2 mm under flush.
  - The center of the hood should be no more than 0.4 mm over flush and no more than 3.2 mm under flush, with a preferred target of flush (0.0 mm).
- g. Place a straight edge near the outer edges of the hood where tape was placed in Step 10. See Figure 6.

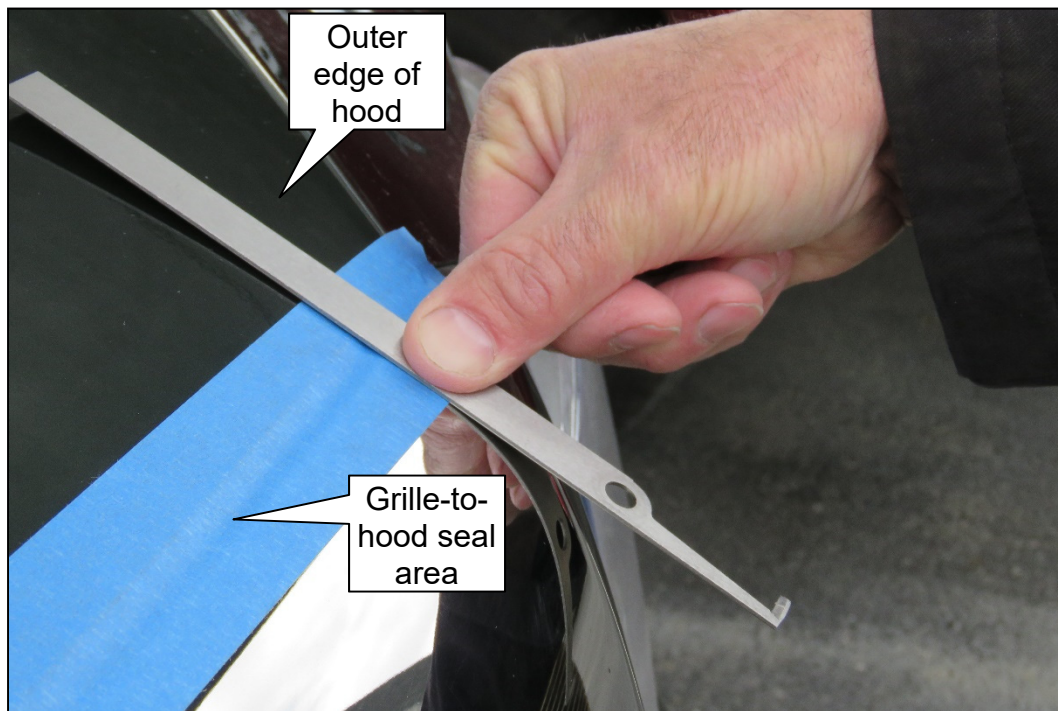
Figure 6

- h. In Figure 6, the grille is over flush with the hood. In this situation, apply finger pressure on the straight edge near the rear edge of the grille as shown. If the grille is under flush with the hood, apply finger pressure on the straight edge near the front edge of the hood.

- j. Subtract the thickness measurement of the straight edge from the measurement taken in step 11i.
  - k. Adjust the hood using the hood bumper rubbers if the hood is more than 0.4 mm over flush or more than 3.2 mm under flush.
    - The outside edges of the hood should be no more than 0.4 mm over flush and no more than 3.2 mm under flush, with a preferred target of flush (0.0 mm).
12. Remove the tape applied in step 10.
